Town of Rockland Community Center At McKinley School

394 Union St. Rockland, MA

Facility Assessment & Planning Study

July 07, 2020

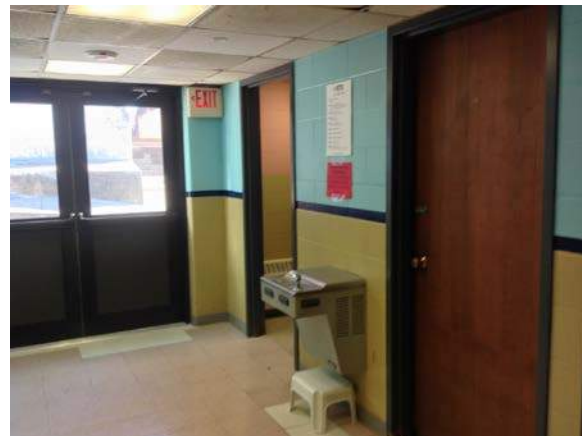
- Existing ceiling tiles are worn and some are damaged. Insulation above some tiles was observed to be moldy and deteriorating. Replacing the tiles, insulation and light fixtures is recommended.

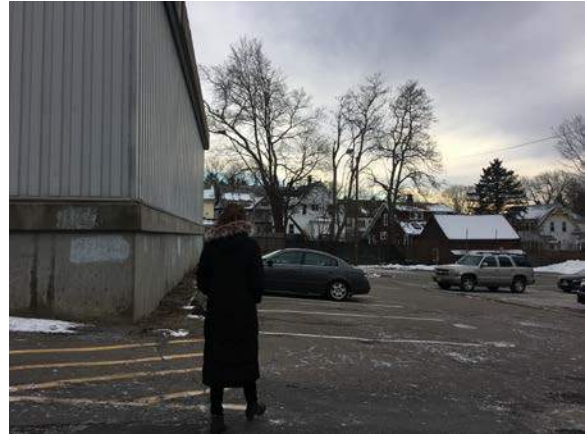
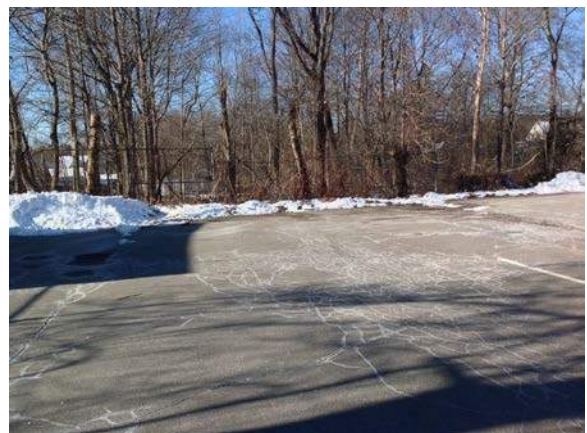
Rear Parking Lot

Behind the building is a large asphalted parking lot, used primarily by staff. The asphalt is in poor condition. There is no pedestrian path from the parking lot to the building, and the pedestrian route connecting to the building is not very pleasant, being walking on the roadway. There are concrete parking curbs at the ends of the spaces along the building. There are no trees for shade in the summer. There appears to be ample space in the lot, and should be reviewed to see if the space could be maximized for either more parking or other functions. There is a paved driveway to the south side of the building.

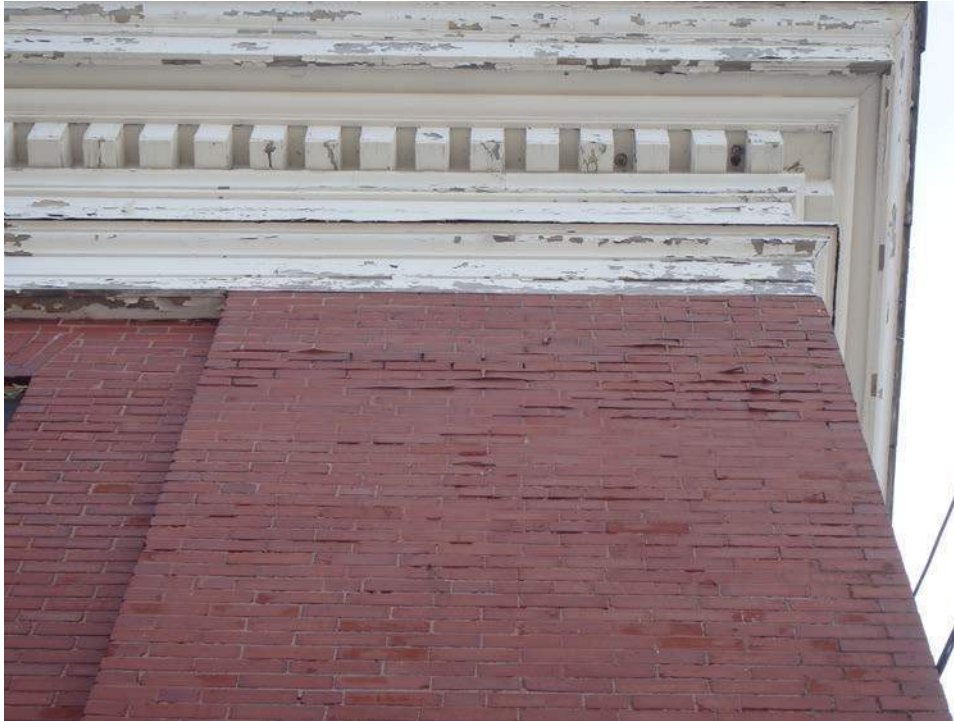
Figure 4. Area of brick infill with poorly matched brick and mortar

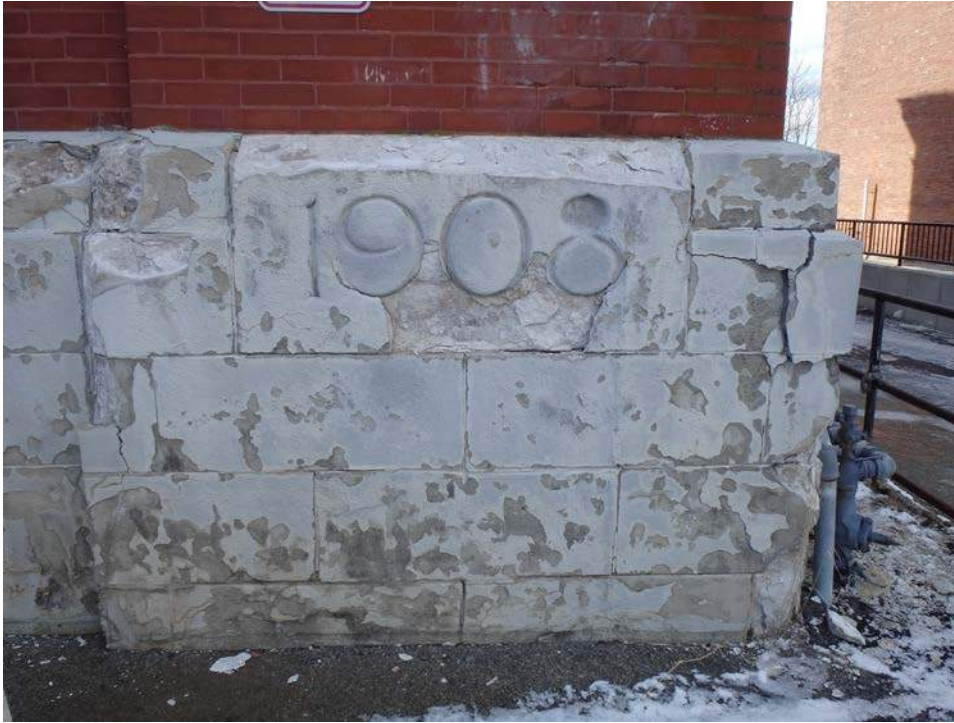
Figure 8. Original cast stone tooling and color exposed under coating

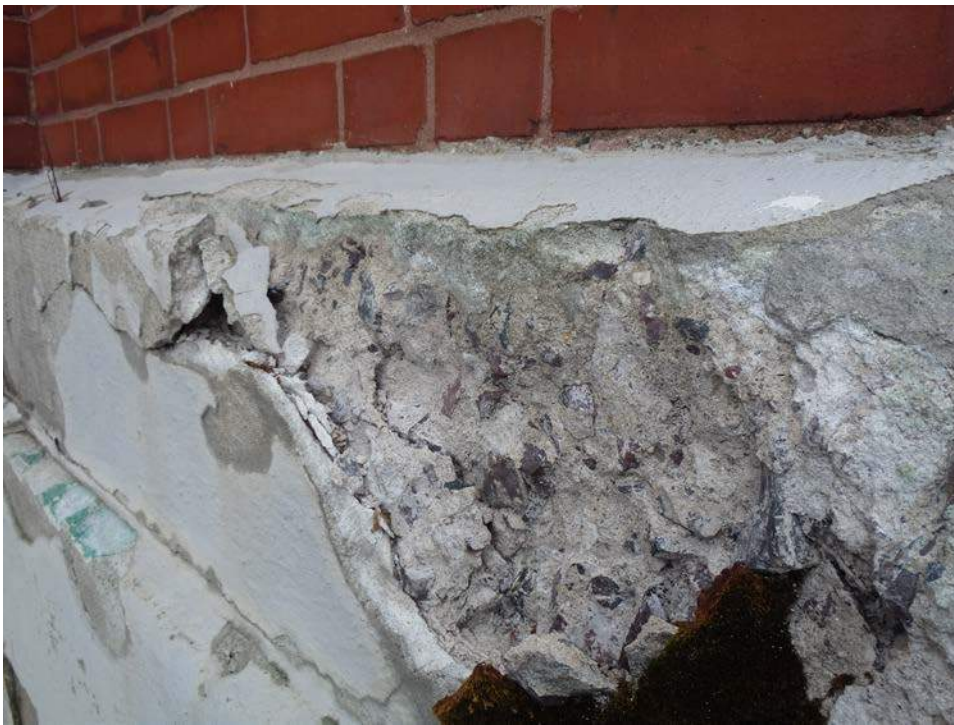
Figure 9. Typical poor condition of foundation cast stone blocks

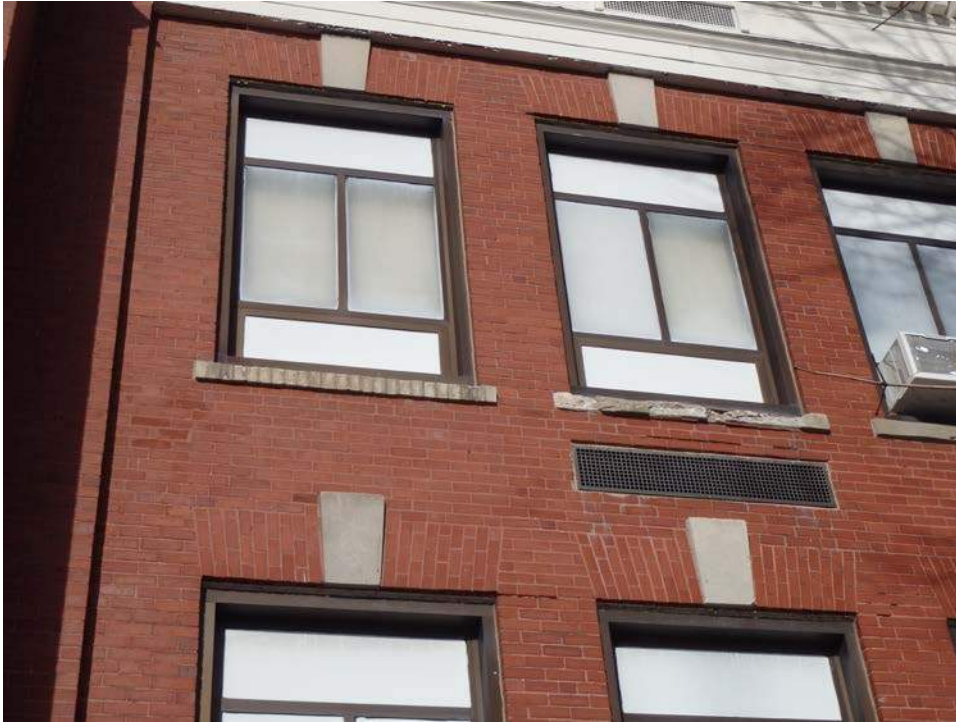
Figure 10. Deteriorated cast stone and purple aggregate (possibly rhyolite)

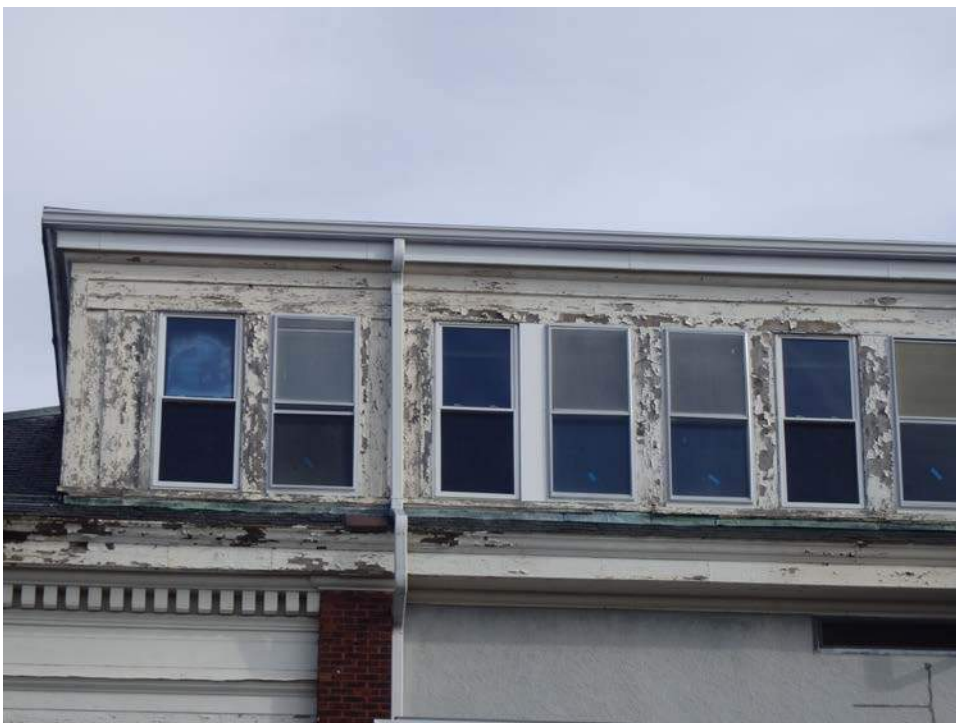
Figure 15. Wood cornice decorative elements intact

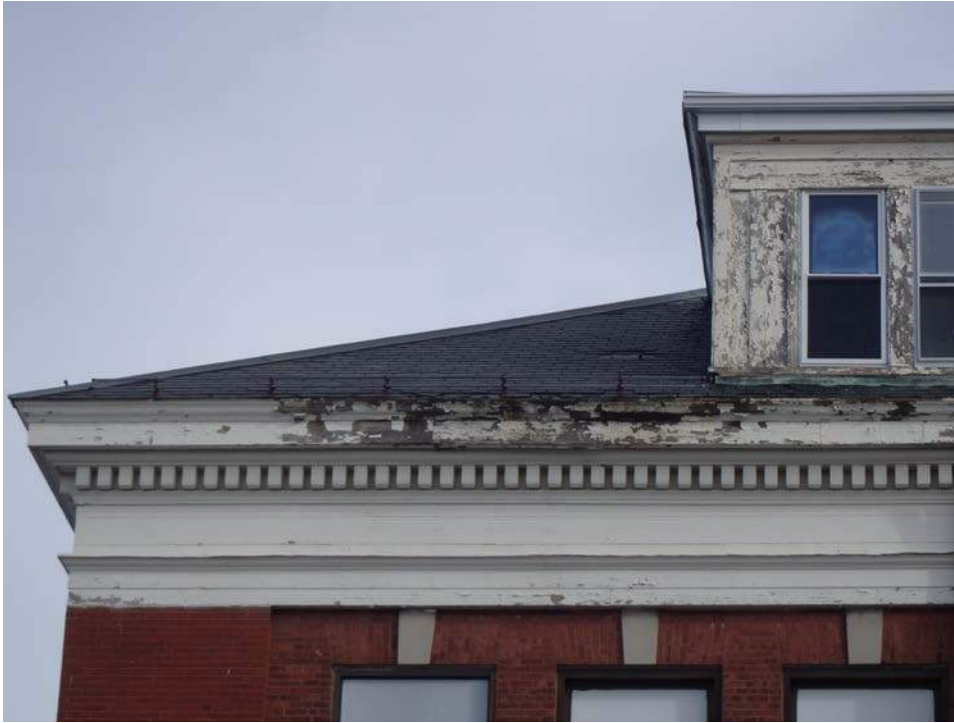
Figure 16. Paint failure and loss is extensive, exposing bare wood

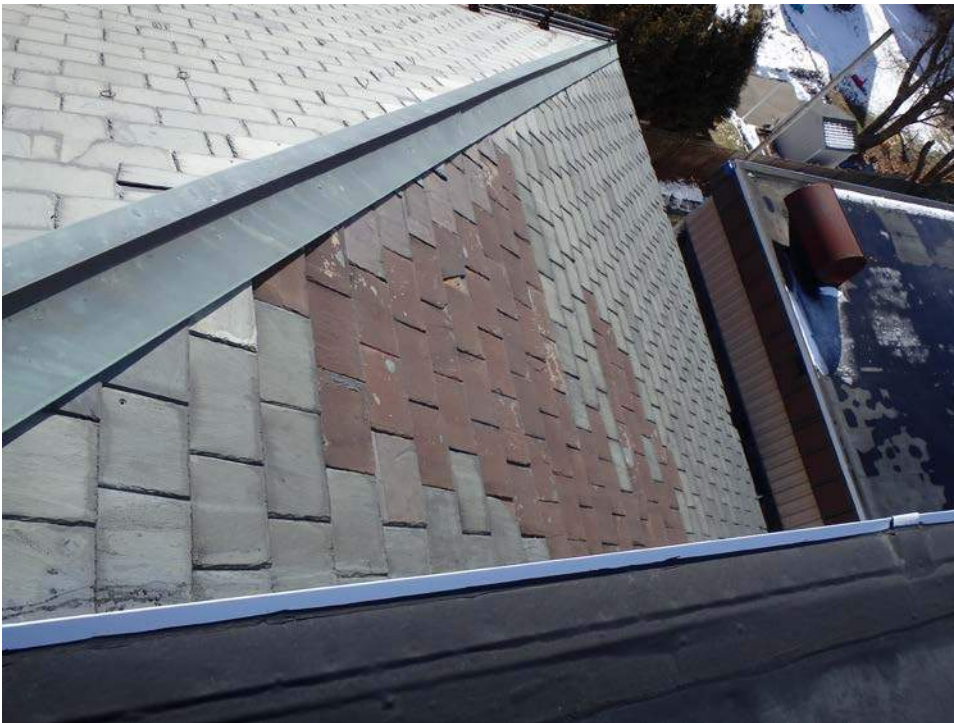
Figure 19. Slate roof showing typical intact condition

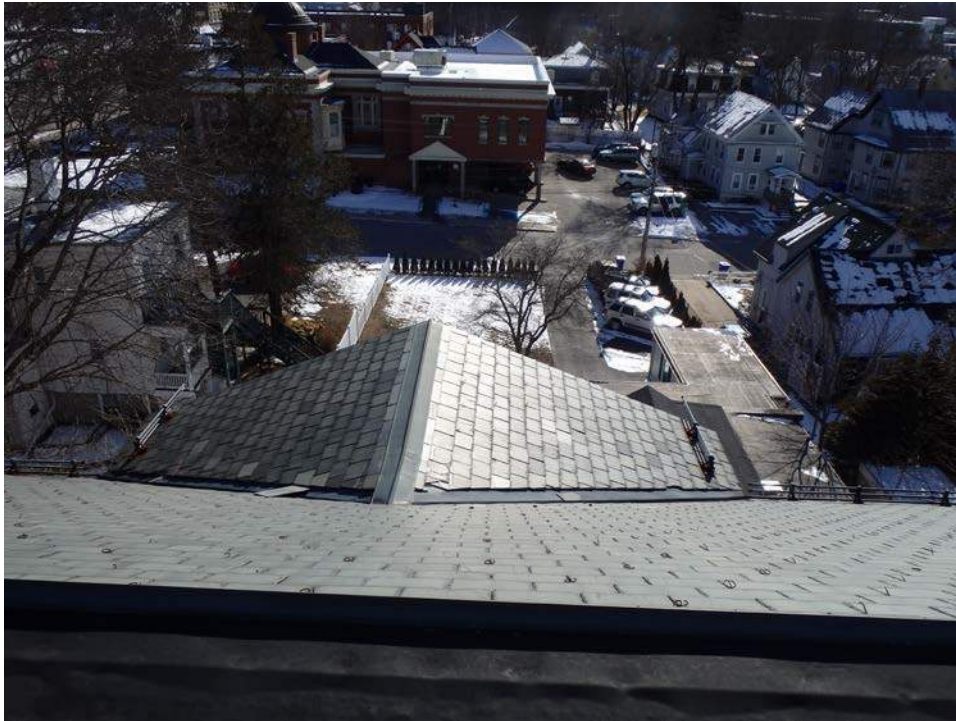
Figure 20. Area of replacement slate on southwestern slope

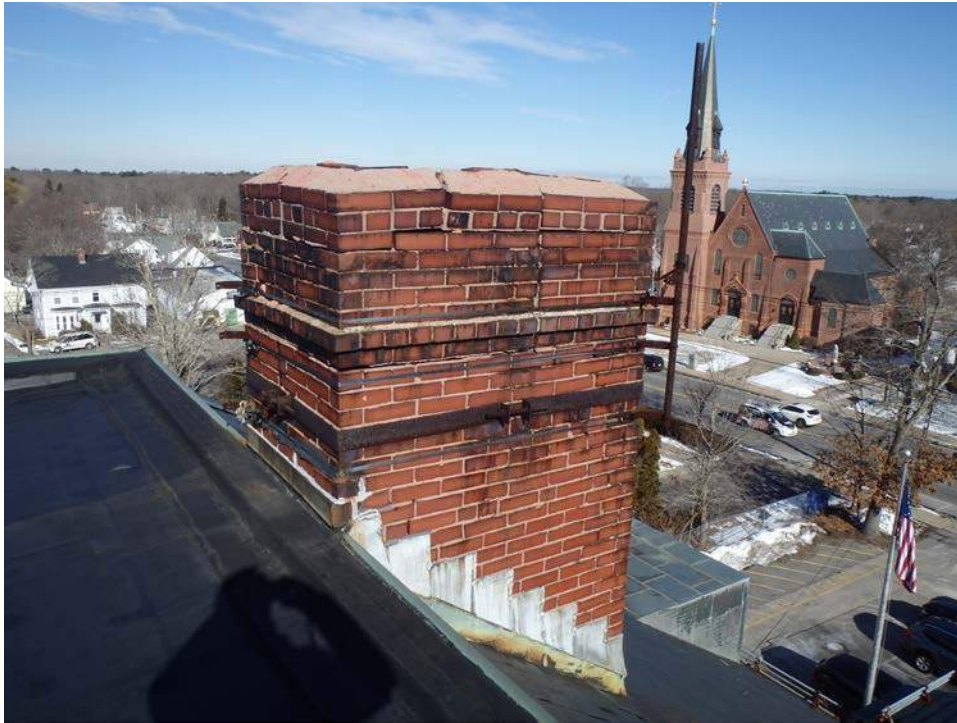
Figure 24. Southeast chimney showing missing brick and open joints

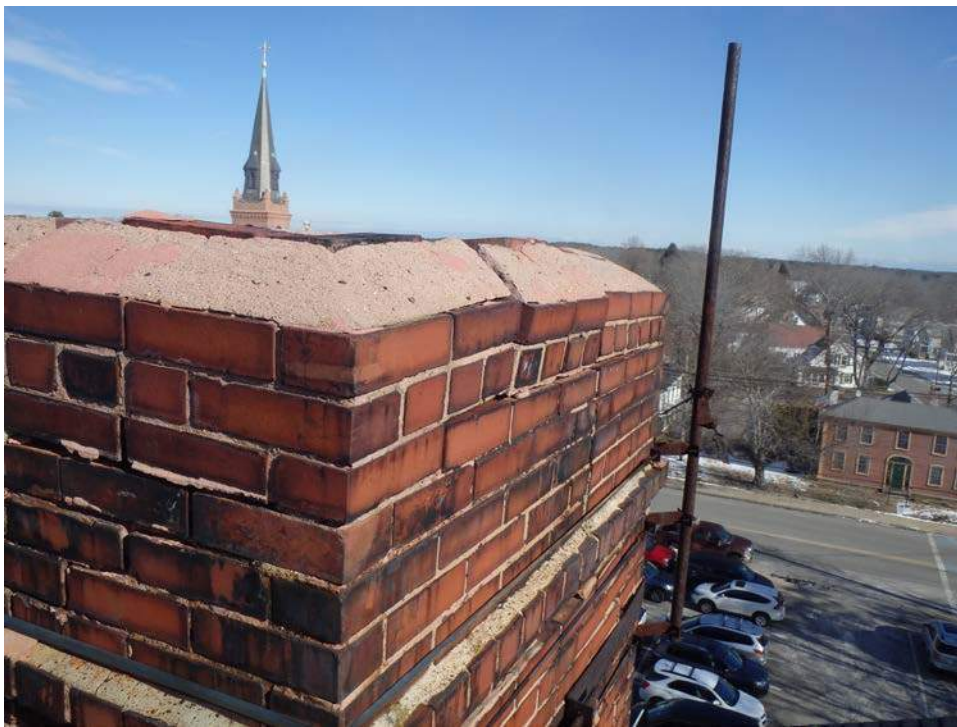
Figure 25. Northeast chimney showing open joints, cracks and iron straps

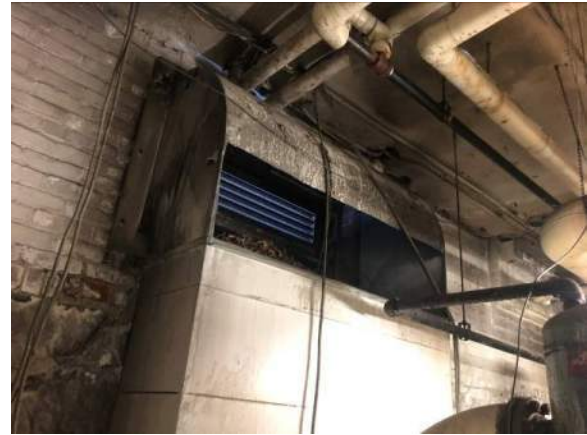
Combustion air for the boiler room is provided through a single existing galvanized sheetmetal duct which has duct openings at approximately 12 inches below the ceiling and 12 inches above the floor. This duct is not provided with a motor operated damper to close off combustion air when the boilers are not operating. The current building code requires motor operated dampers, and therefore this deficiency makes the current installation non code compliant.

Existing Combustion Air Duct, Low Opening (left) and High Opening (right)

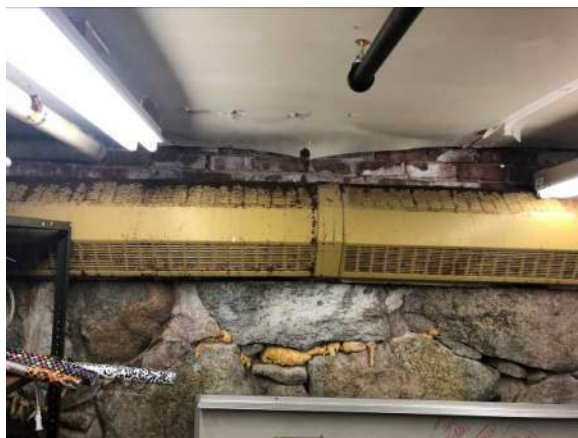
Storage rooms in the basement and on the third floor are typically heated by wall mounted fin tube radiation heating. The basement fin tube radiation and enclosures appear to be in poor condition. The third floor radiation appears to be in fair condition.

Basement Storage Room – Fin Tube Radiation
