Town of Rockland Community Center At McKinley School

394 Union St. Rockland, MA

Facility Assessment & Planning Study

July 07, 2020

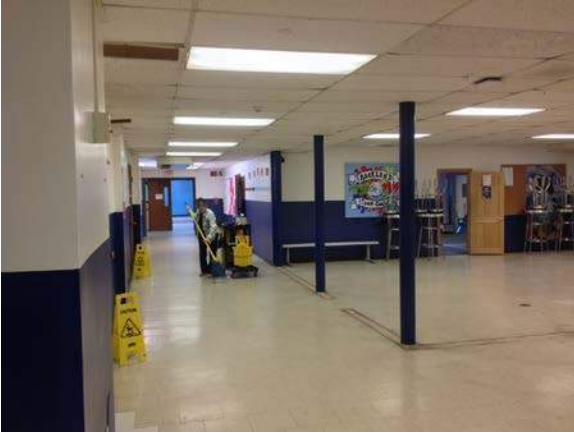
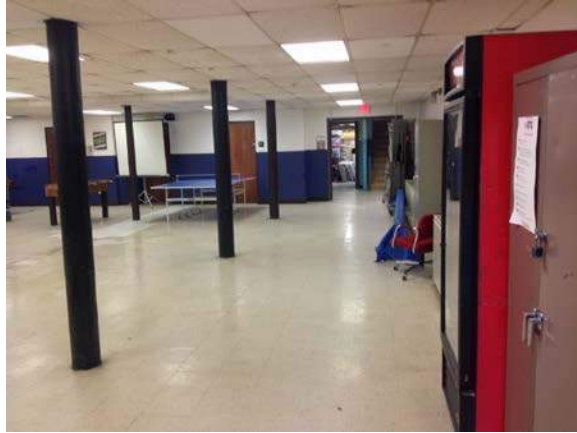
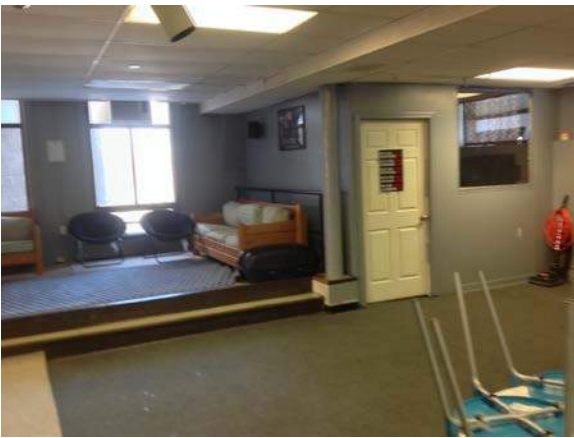
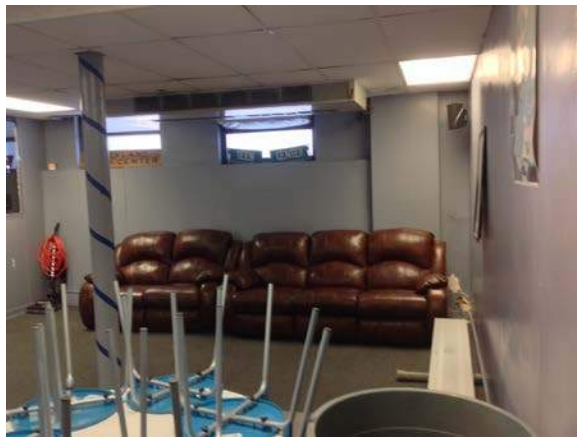
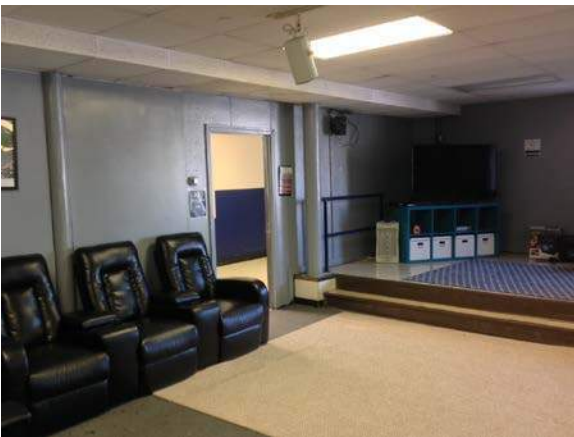
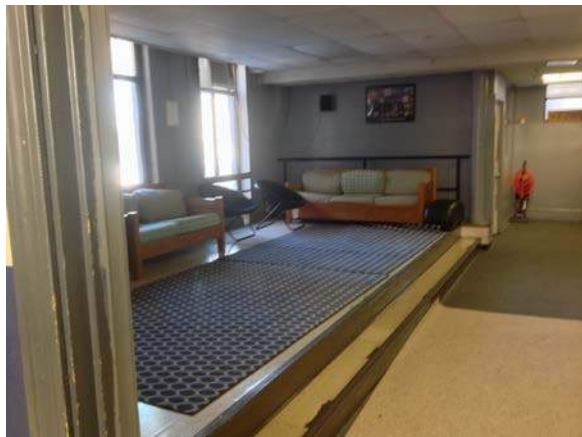
- Worn but comfortable vibe
- Space not well defined and bleeds into other spaces
- Supervision and security may be a concern related to visibility in the current layout
- Game room could be something more/better
- Access to bathrooms is hard to supervise
- The structure creates a challenge when considering an open plan layout
- Limited natural light
- Feels institutional
- Circulation for the entire floor passes through this space

- Existing ceiling tiles are worn and some are damaged. Replacing the tiles and light fixtures could be an option to minimally improve the space. Alternatively, creating some different ceiling types and heights could give the space some new dimension and character. Varying the ceiling heights could also create “zones” in the currently very open layout.

- Recommend replacing existing VCT with a vinyl tile or plank for improved appearance, durability and cleanability. Tiles and planks are also easily replaced as required for future maintenance.

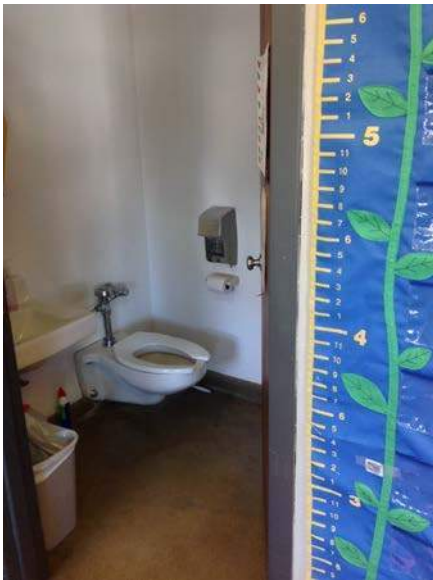
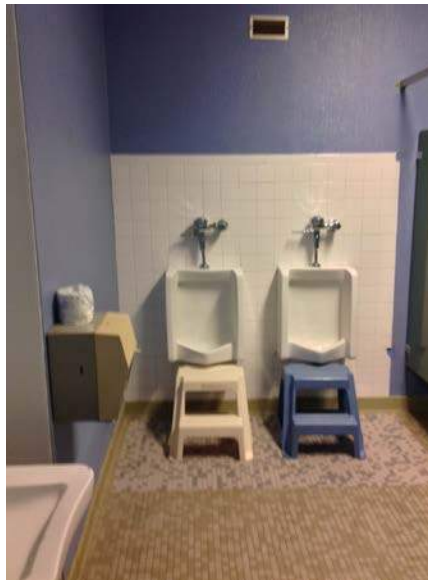
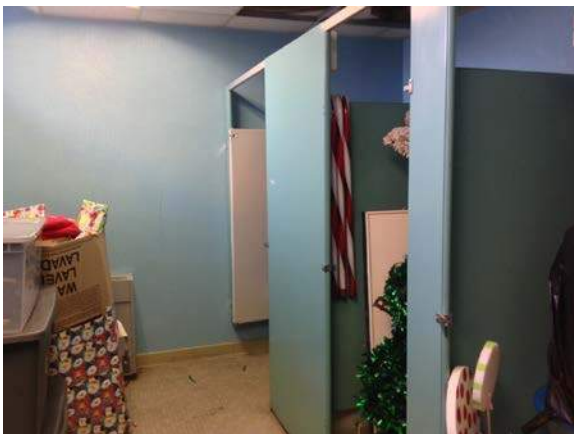
Restrooms

- Existing ceiling tiles are worn and some are damaged. Replacing the tiles and light fixtures is recommended.

- Recommend replacing existing flooring with a vinyl sheet good for improved appearance, durability and cleanability.

- Recommend removing old finishes and repainting

- Recommend fixtures & accessories used by children to be of appropriate size & height

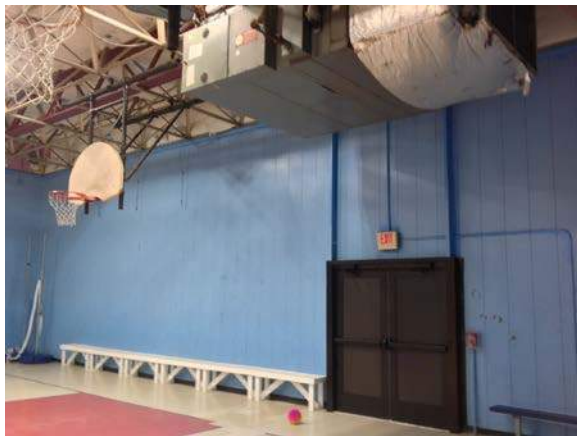
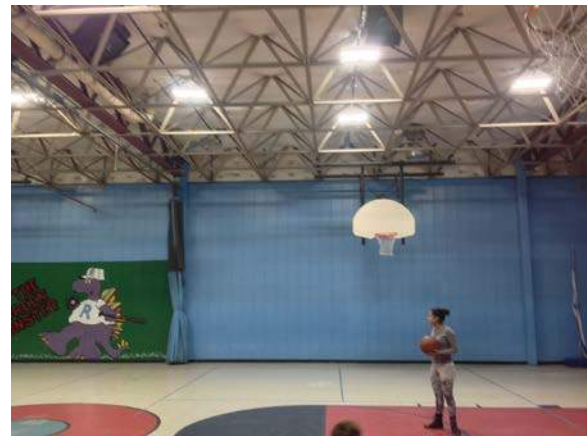
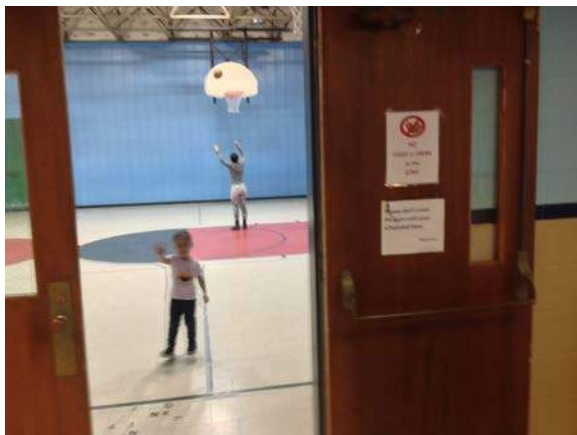
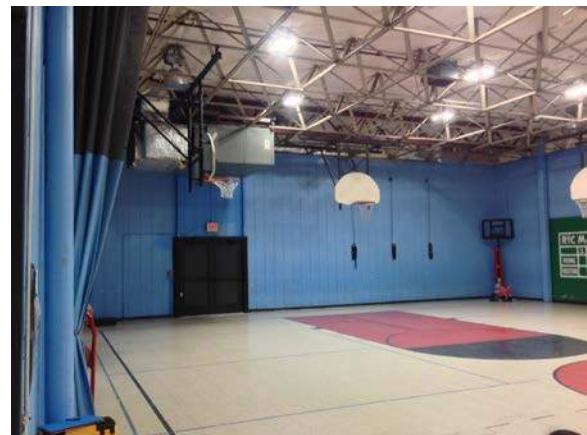
Gymnasium:

- Appear worn and mildly damaged – painting would improve aesthetics but damage would remain

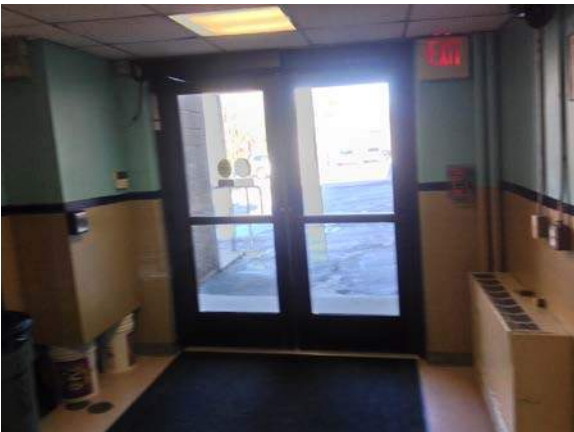
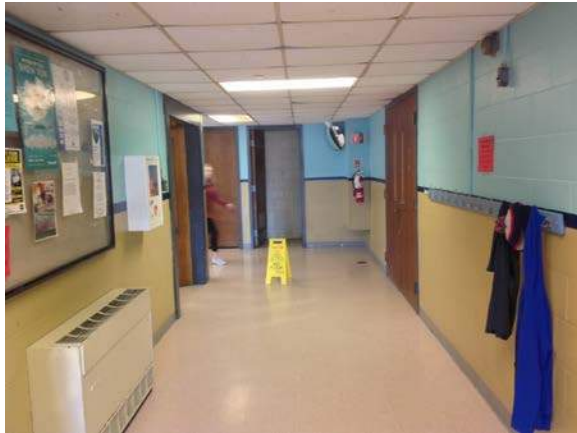
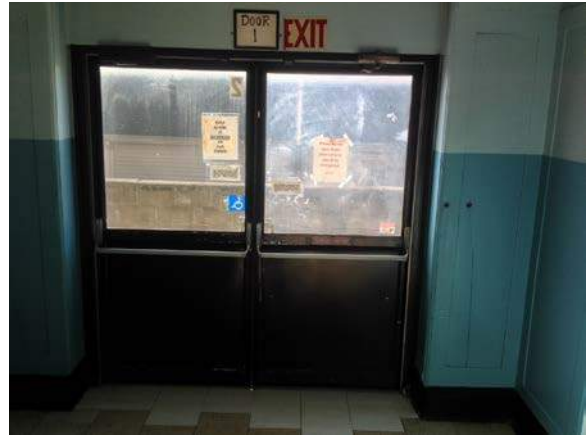
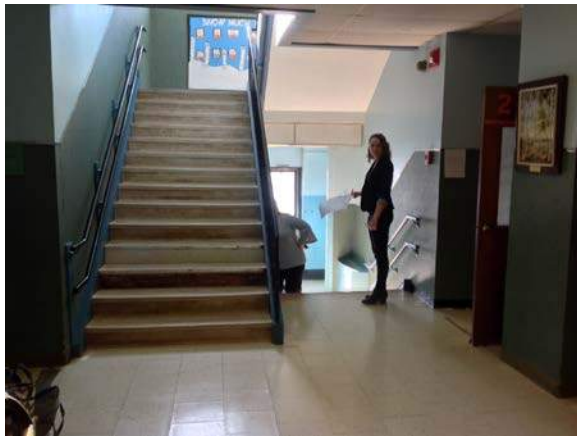
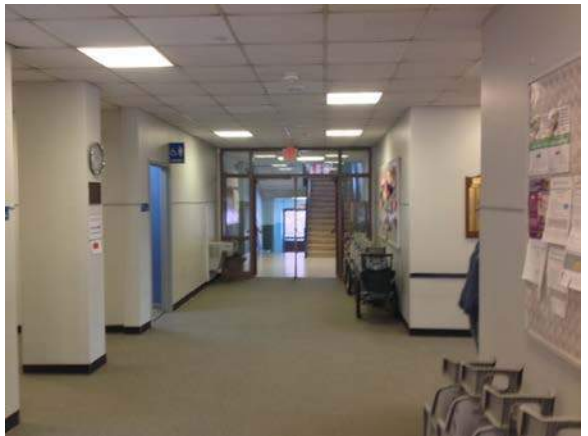
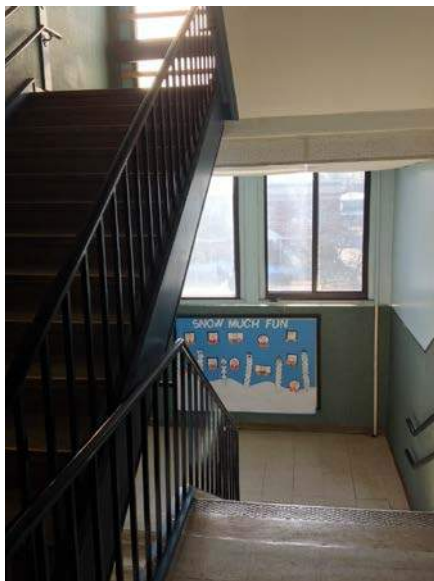
Corridors & Stairs

- Overall look feels institutional
- Existing finishes are worn and tired
- Challenging to secure and supervise movement throughout the building
- Currently limited to no way finding features
- Windows appear to need improvement or replacement

- Existing ceiling tiles are worn and some are damaged. Insulation above some tiles was observed to be moldy and deteriorating. Replacing the tiles, insulation and light fixtures is recommended.

- Recommend replacing existing VCT in corridors with a vinyl tile or plank for improved appearance, durability and cleanability. Tiles and planks are also easily replaced as required for future maintenance.
- New tread & riser material on stairs is recommended
- Railings appear to be in good shape but could be refreshed with new paint

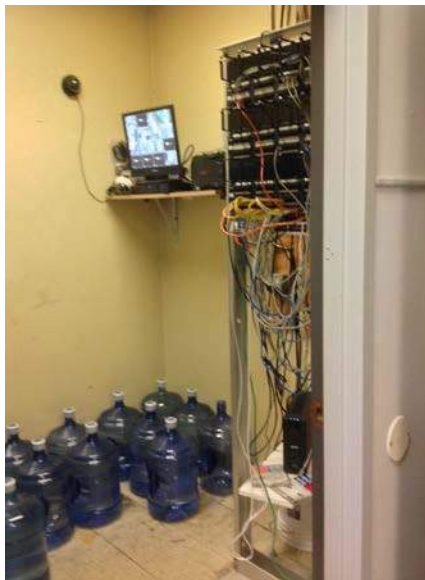
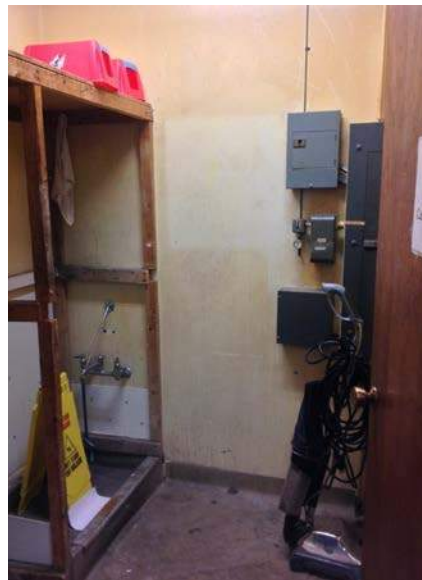
Support Spaces:

- Existing ceiling tiles are worn and some are damaged. Replacing the tiles, insulation and light fixtures is recommended.

- Recommend replacing existing VCT with a vinyl tile or plank for improved appearance, durability and cleanability. Tiles and planks are also easily replaced as required for future maintenance.

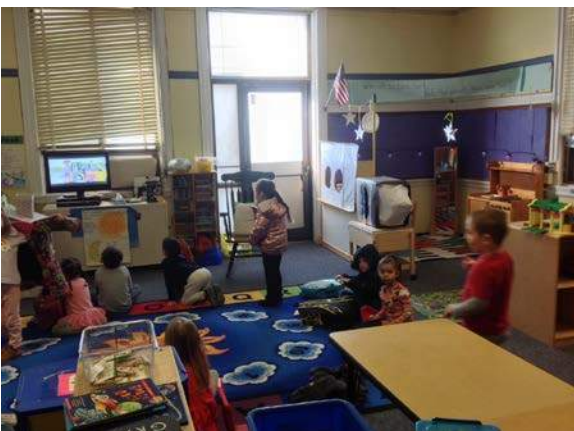
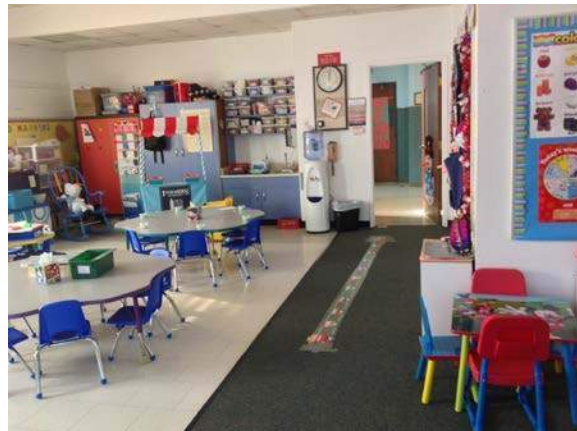
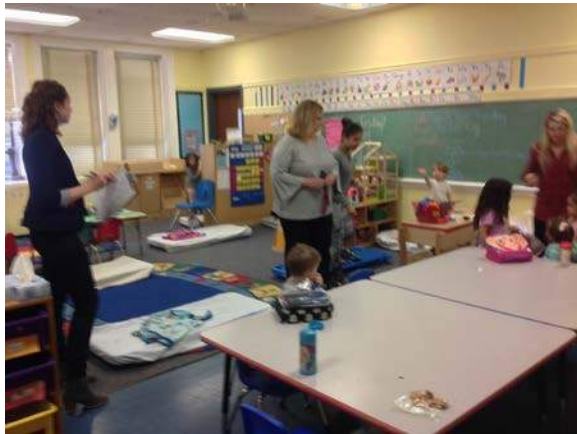
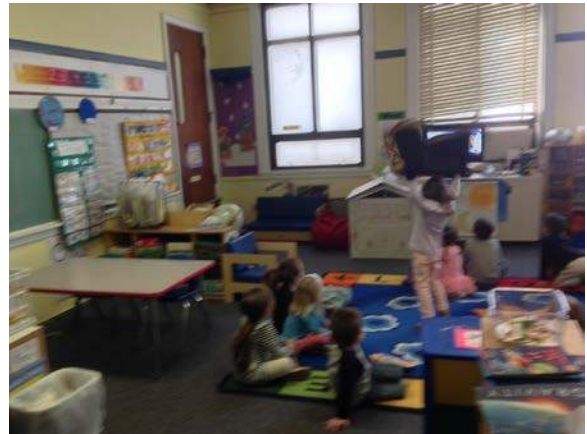
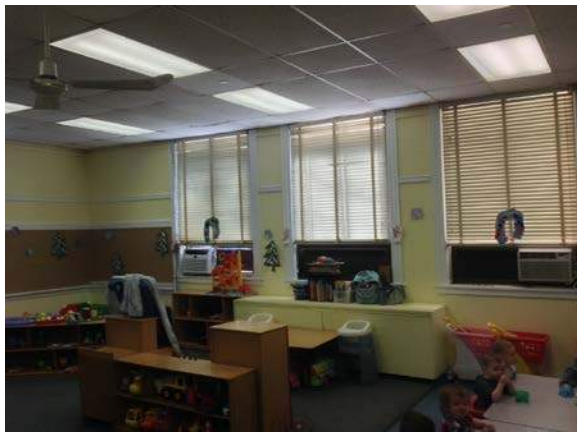
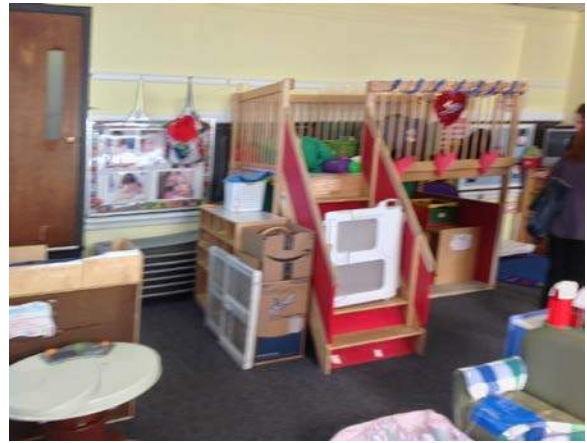
Rockland Day Care Classrooms:

- Existing ceiling tiles are worn and some are damaged. Replacing the tiles, insulation and light fixtures is recommended.

- Recommend replacing existing flooring with a vinyl tile or plank for improved appearance, durability and cleanability. Tiles and planks are also easily replaced as required for future maintenance.

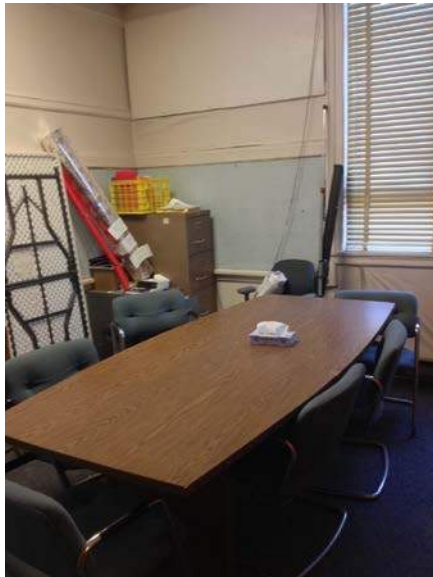
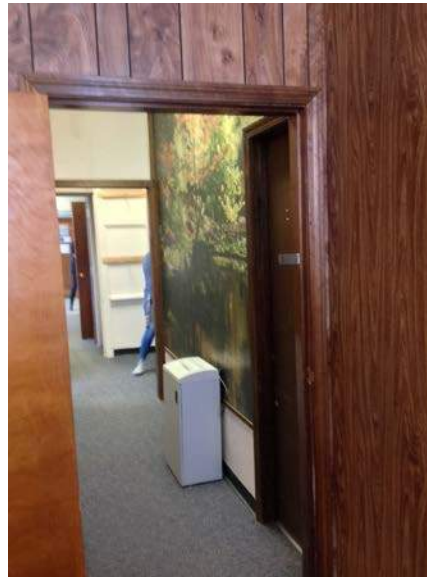
Daycare Offices:

- Carpet doesn't appear damaged but new is recommended

- Wood paneling and wall covering appears dated. Removing these and repainting is recommended.

- Existing ceiling tiles are worn and some are damaged. Replacing the tiles, insulation and light fixtures is recommended.

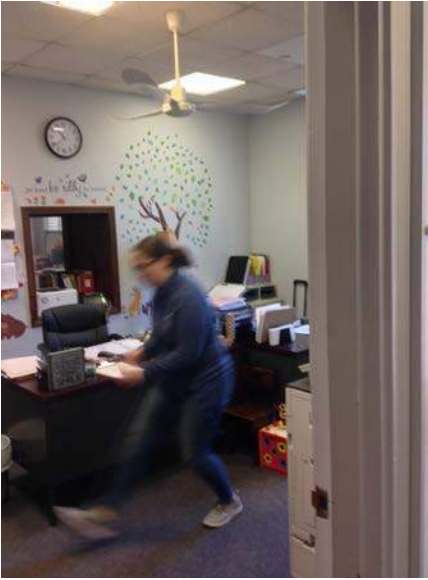
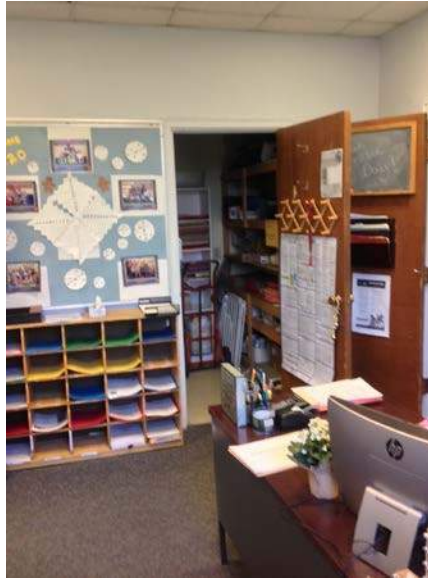
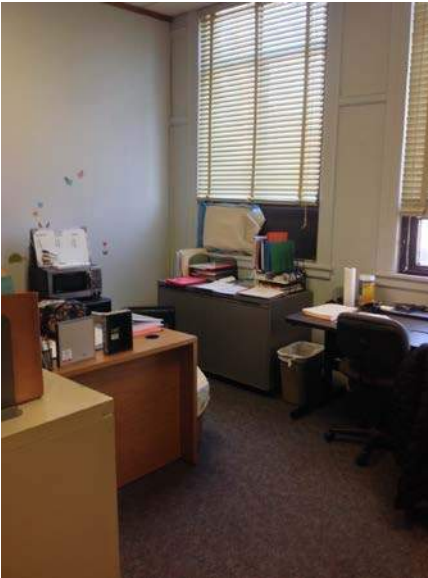
Youth Commission Offices:

- Carpet doesn't appear damaged but new is recommended

- Existing ceiling tiles are worn and some are damaged. Replacing the tiles, insulation and light fixtures is recommended.

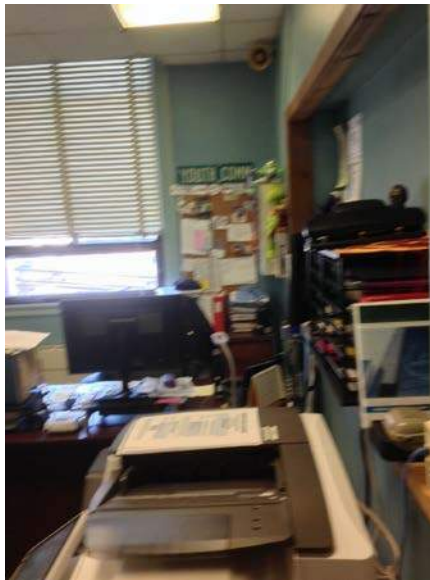
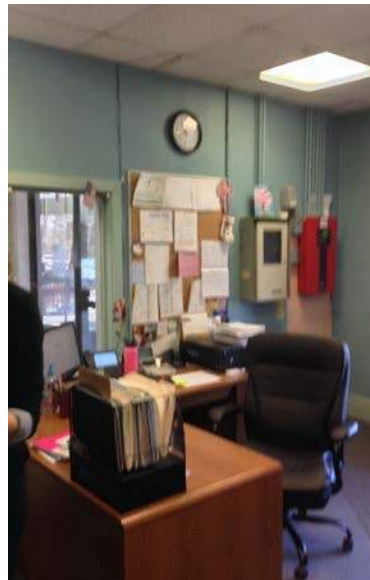
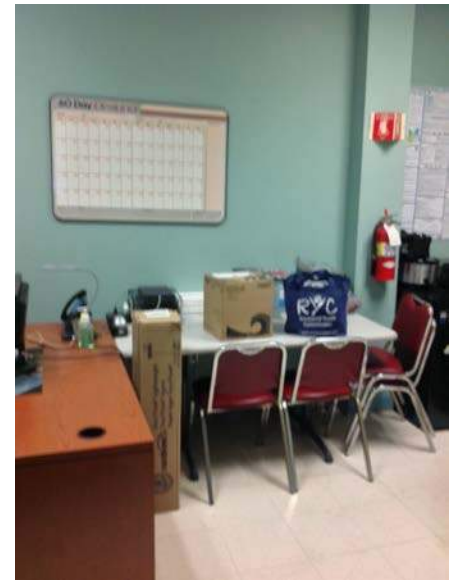
Community Room:

- Existing ceiling tiles are worn and some are damaged. Replacing the tiles and light fixtures could be an option to minimally improve the space. Alternatively, creating some different ceiling types and heights could give the space some new dimension and character. Varying the ceiling heights could also create “zones” in the currently very open layout.

- Recommend replacing existing VCT with a vinyl tile or plank for improved appearance, durability and cleanability. Tiles and planks are also easily replaced as required for future maintenance.

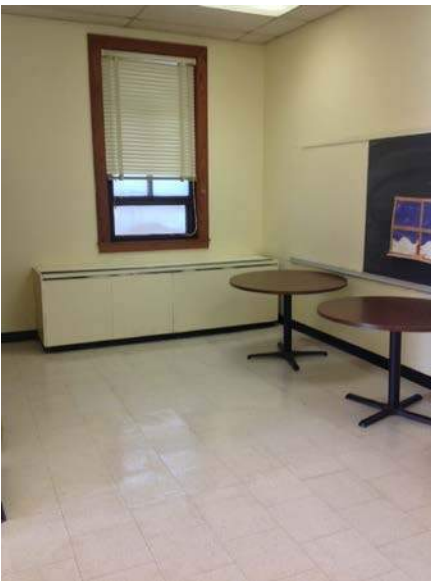
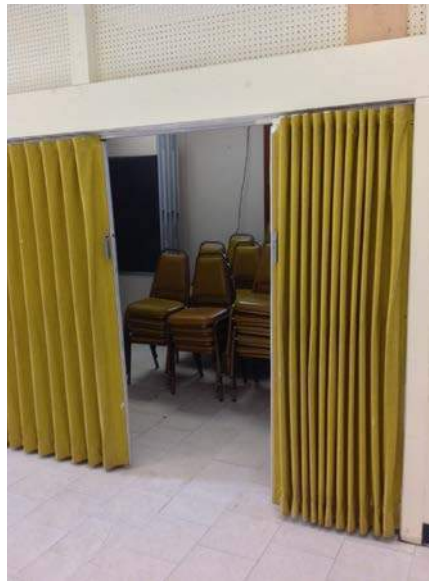
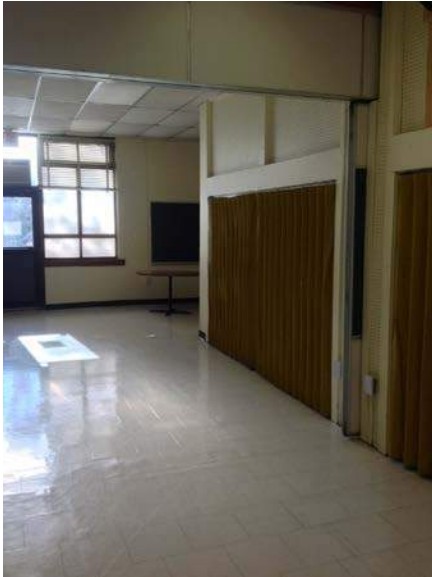
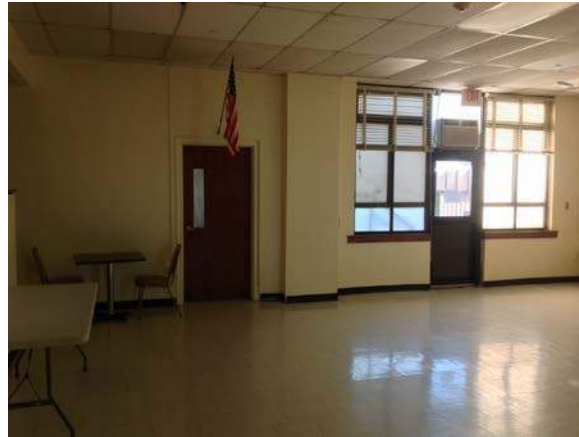
2nd Floor Staff Room

- Existing ceiling tiles are worn and some are damaged. Replacing the tiles and light fixtures is recommended.

- Recommend replacing existing carpet with a vinyl tile or plank for improved appearance, durability and cleanability. Tiles and planks are also easily replaced as required for future maintenance

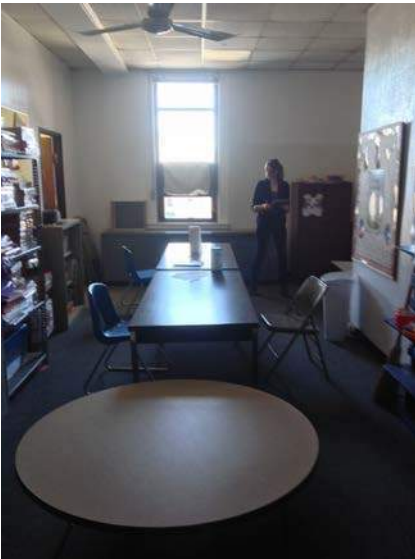
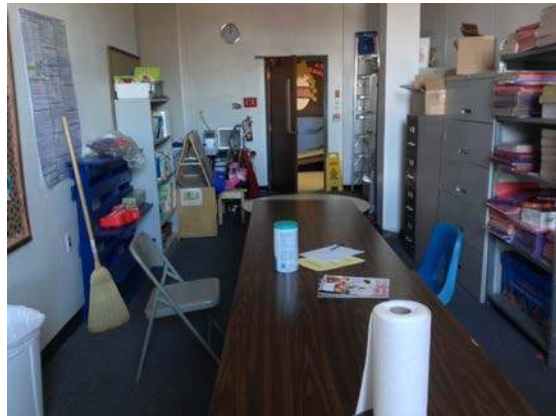
Vacant 3rd Floor:

- Existing ceiling tiles are worn and some are damaged. Replacing the tiles and light fixtures is recommended.

- Recommend replacing existing flooring with new. Flooring type would depend on future programming but would likely be carpet tiles or vinyl tile

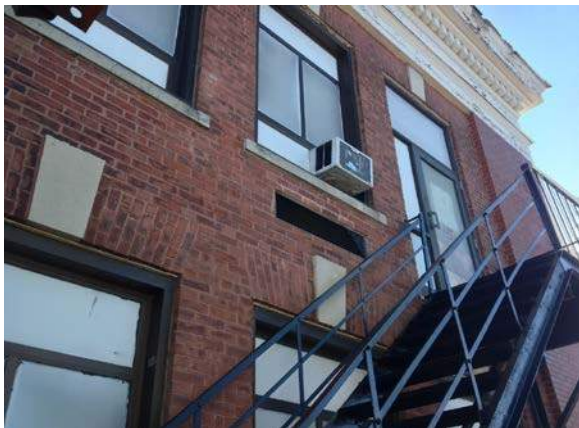
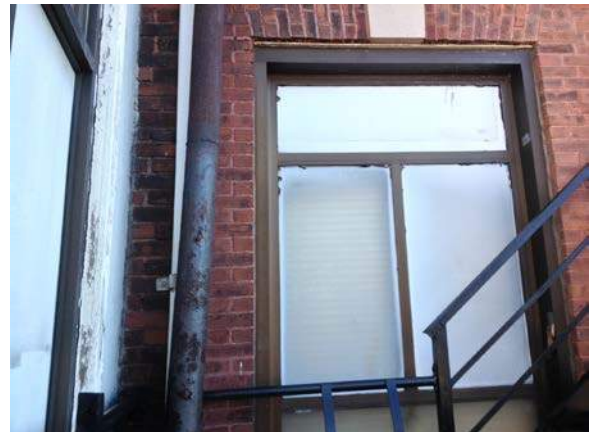
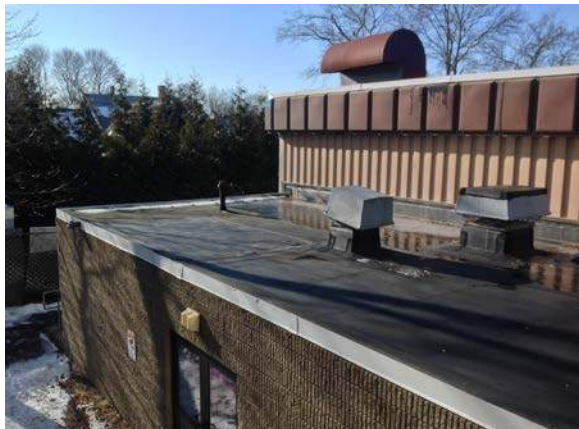
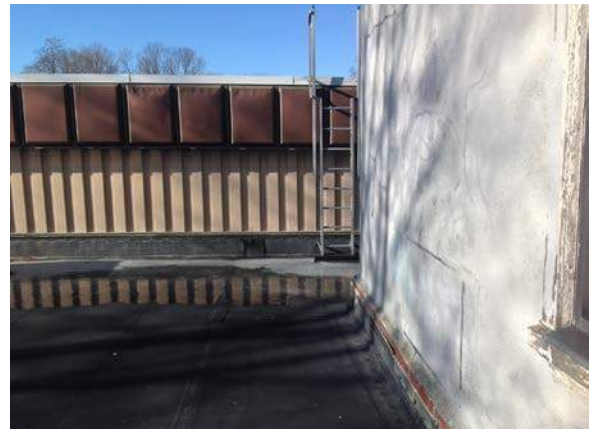
Exterior:

- Membrane roof has been recently upgraded
- Ponding observed on membrane roofs but no current reported leaks
- Areas of pavement are uneven and may be an egress issue
- Recommend the town checks the fire escape inspection reports
- Snow rail is reported to be ineffective in some areas – falling ice restricts pedestrian movement at perimeter of building
- Issues reported of falling slate shingles

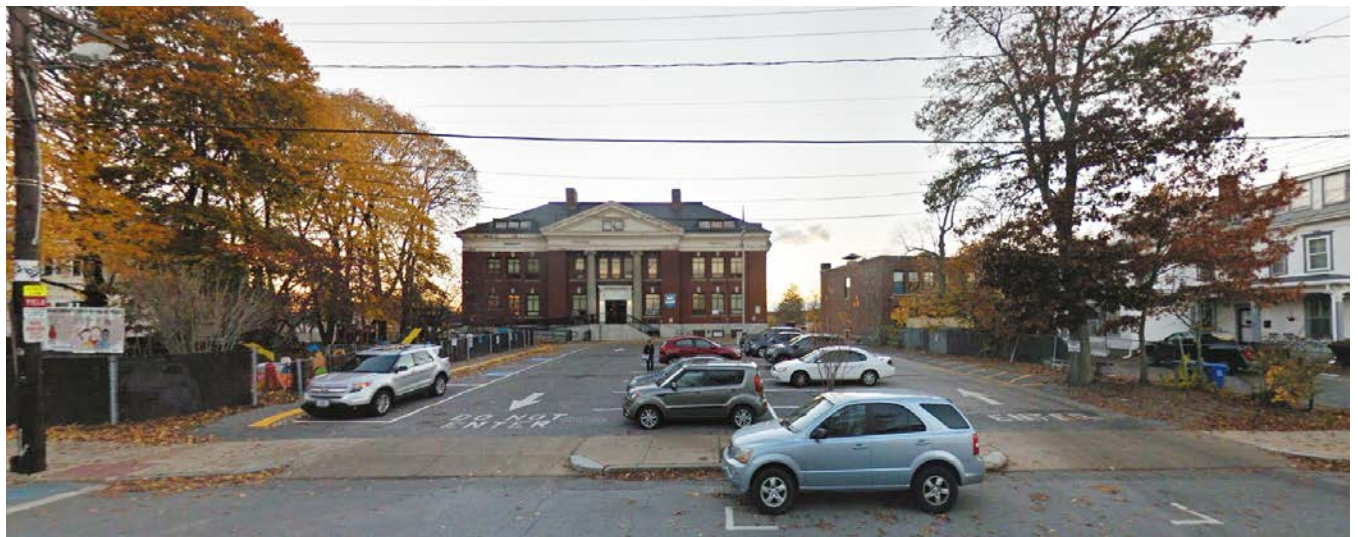
View from Union Street

The area in front of the building is currently an asphalt parking lot and the view of the building from the street is not very attractive or inviting and does not complement the building. There is no sign and the asphalt parking lot directly abuts the Union Street sidewalk. There is a crosswalk across Union St. that connects with the sidewalk to the building entry. Options should be explored of how to re-configure the front 'yard' to create a more attractive and inviting front entry to the building with landscaping and clear signage, without reducing the amount of parking.

The asphalt surface is not in good condition, with many cracks and should be replaced.

The entire front area needs to be re-looked at to ascertain if there is a more efficient parking layout that could yield more parking spaces. The area needs to be reviewed to ensure that it has adequate drainage.

It appears that there is some extra space along the right-hand side of the entrance aisle which could provide the extra space needed for either additional parking and/or make room for the desired landscaped area in front of the building.

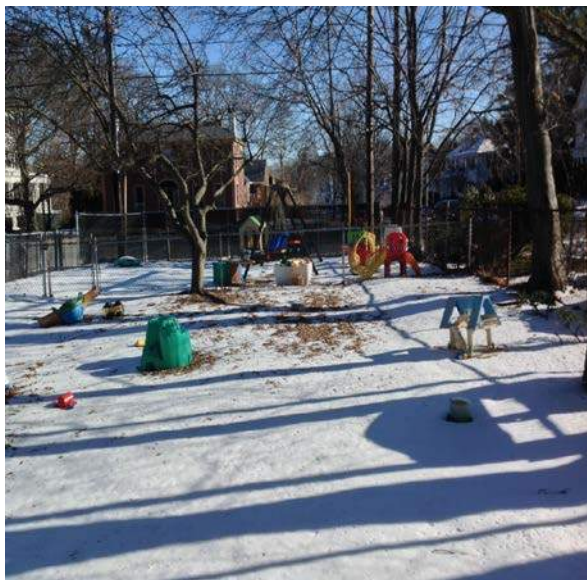
The entire perimeter chain link fencing is in need of repair, with missing caps and missing fence slats.

Playground looking towards Union St.

A better use for the area along Union Street may be for a public pocket park with landscaping and seating, providing a more attractive landscaped area along Union Street and in keeping with the Rockland Streetscape Plan.

The play areas need to be checked for the required square footage for child care licensing.

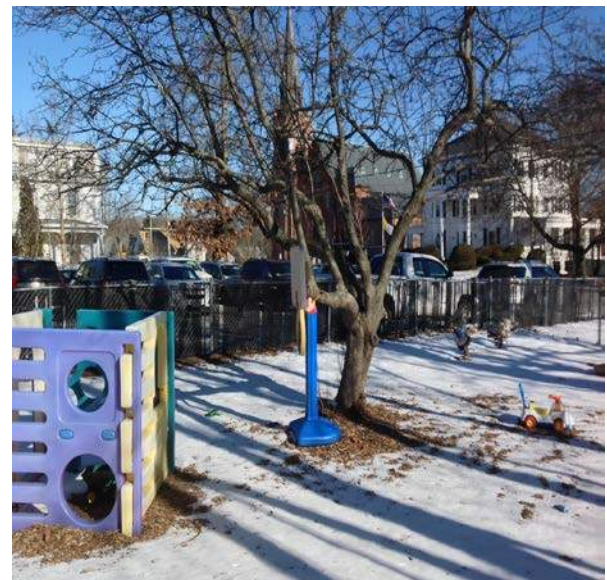
Playground looking towards parking lot.

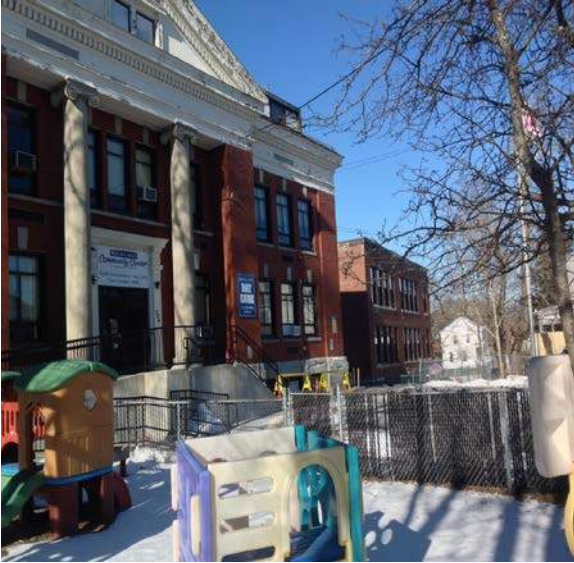
Playground looking towards building.

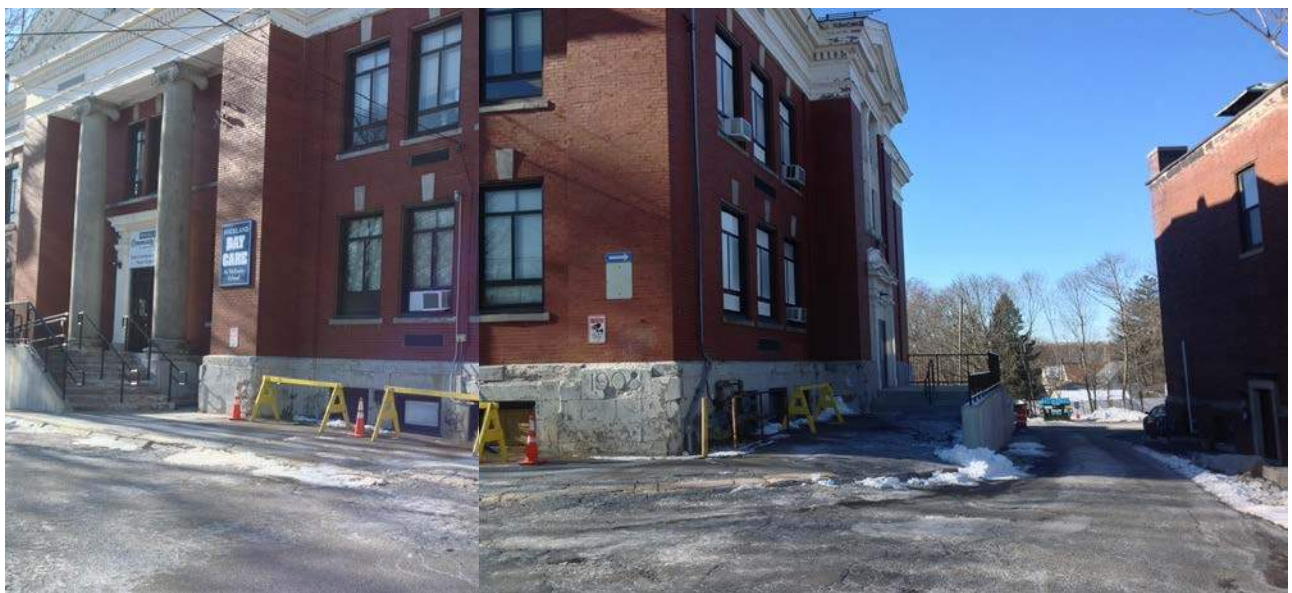
The existing drive connecting the front and rear parking lots runs along the north side of the building. Asphalt paving extends up to the base of the building and there is no delineation between pedestrian zones and vehicular drives.

There is no signage directing vehicles, and the un-used steps entrance is confusing.

The asphalt driveway continues down from the front parking area to the rear parking lot. Along the driveway there is the north building entrance, another driveway entrance on the right to the neighboring property's parking, dumpster, and additional parking on the sides of the driveway, making a confusing area. There are no pedestrian zones or any demarcation of the edge of the driveway.

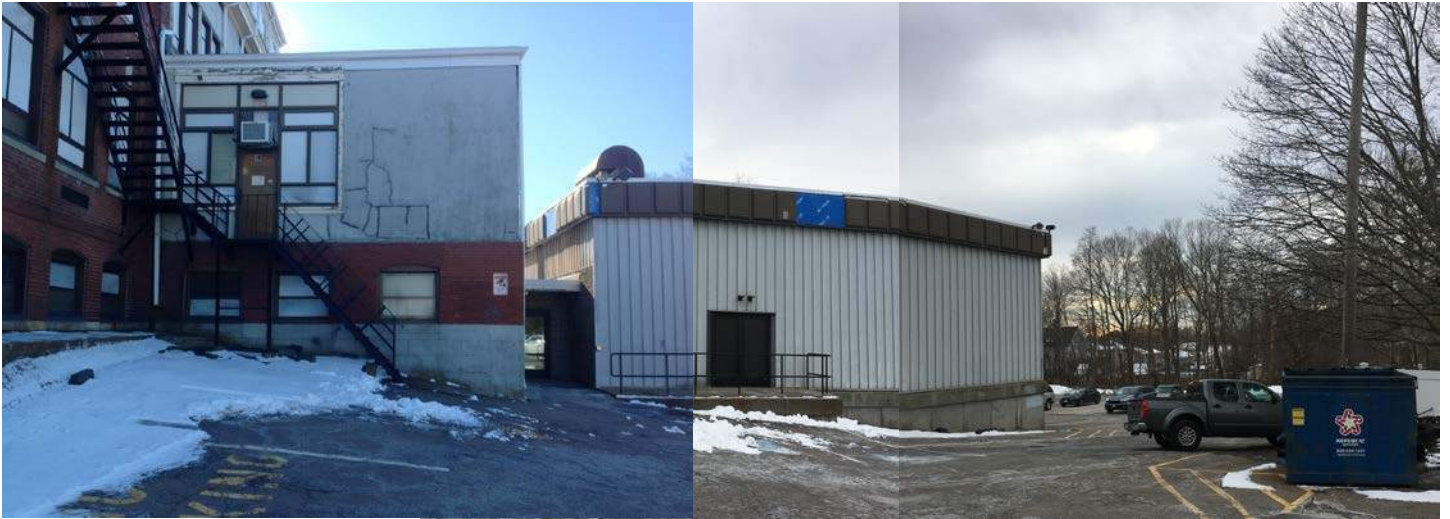
Driveway connecting front and rear parking lots

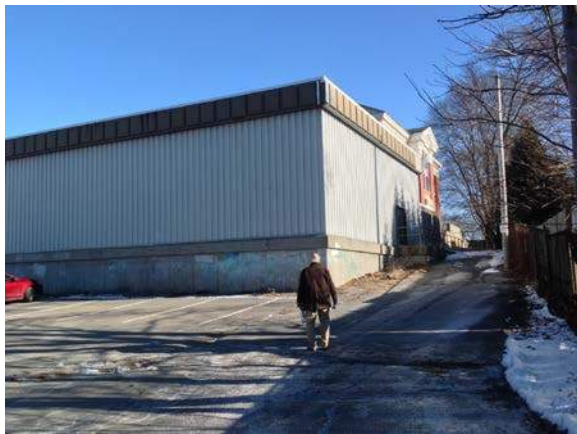
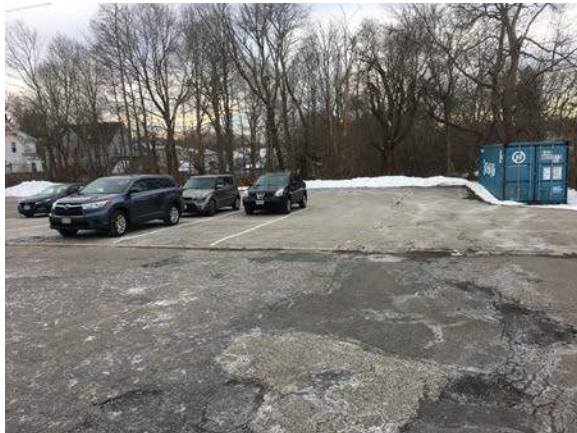
Behind the building is a large asphalted parking lot, used primarily by staff. The asphalt is in poor condition. There is no pedestrian path from the parking lot to the building, and the pedestrian route connecting to the building is not very pleasant, being walking on the roadway. There are concrete parking curbs at the ends of the spaces along the building. There are no trees for shade in the summer. There appears to be ample space in the lot, and should be reviewed to see if the space could be maximized for either more parking or other functions. There is a paved driveway to the south side of the building.

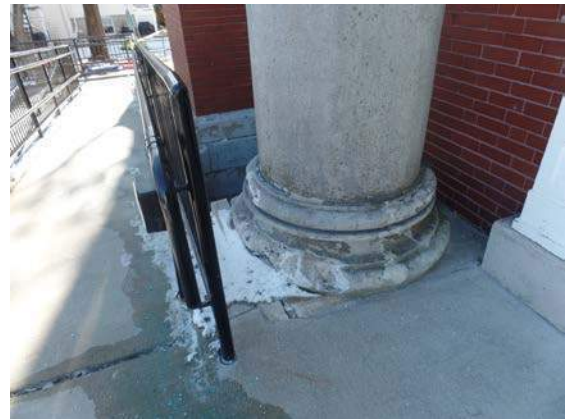
1. Exterior Façade: Original cast stone and masonry façade elements are showing signs of weathering and deterioration; particularly at the bases of the ionic entry columns (Photo) and at cast stone elements around the base of the building. There are open masonry joints at various locations around the building that require repointing (approximately 10% to 20% of the total façade area). ***Repair/restoration of masonry and cast stone elements is recommended, in conjunction with a future renovation of the building.***

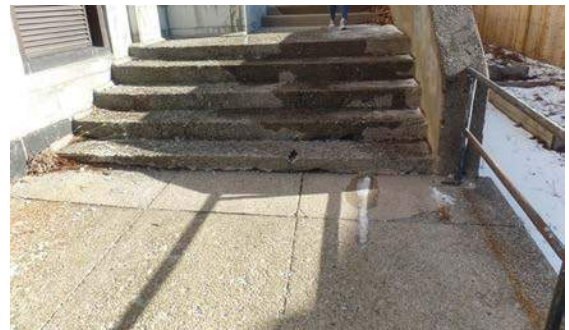
2. The concrete stairs/terrace along the south edge of the building shows signs of significant deterioration (Photo). Portions of this area are framed with steel beams, which have rusted and spalled their concrete cover. Water infiltration at the slab/building interface may have damaged first floor wood framing as well. Wood framing near the main entrance on the east side may be similarly compromised.

Repair/reconstruction of the stairs/terrace and wood framing at the entries is recommended, in conjunction with a future renovation of the building. In the interim, these conditions should be periodically monitored and shored/closed if conditions deteriorate significantly further.

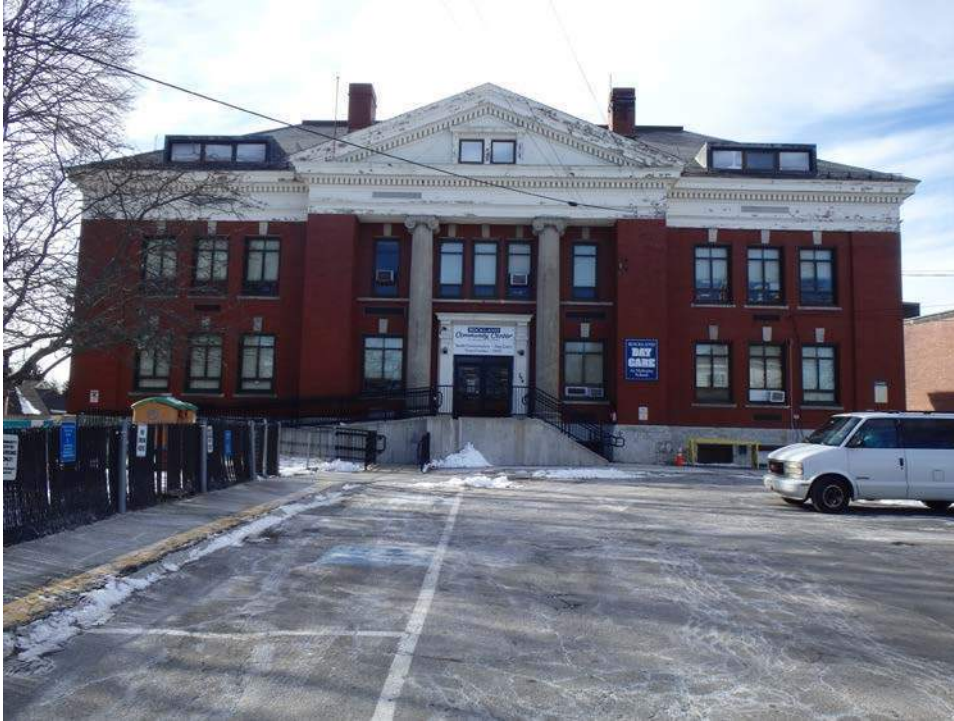
The McKinley School was designed by architect Frank Irving Cooper and constructed in 1908. The building is Colonial Revival style with cast stone foundation blocks, window headers, windowsills, and full height columns and bases on the north elevation; brick walls; and, wood pediments and cornices. The building was placed on the National Register of Historic Places in 1989. (Fig. 1)

Figure 1. East elevation, front façade

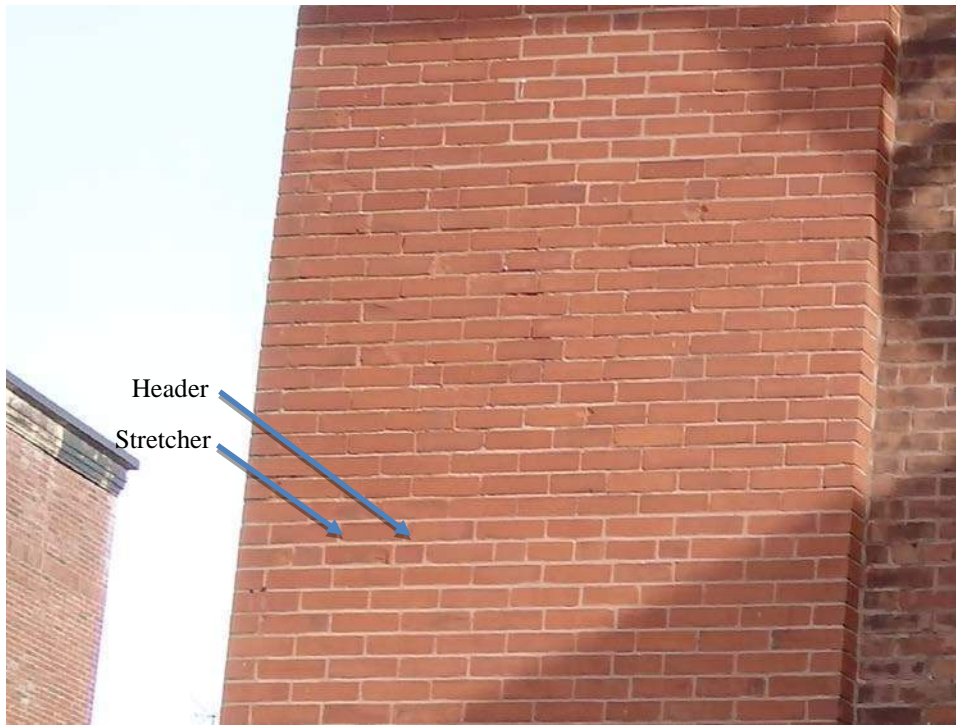
The brick walls are laid up in a modified common bond (header/stretcher course every 8th course) (Fig. 2). The use of a brick bond indicates multi-wythe brick construction, but with the 1908 date of construction, there could be structural steel used as the main support for the structure. There is no indication of vertical cracking at corners, so if there is structural steel, it is most likely not embedded in the masonry as was common practice at the time.

Figure 2. Modified common bond with header/stretcher course every 8th course

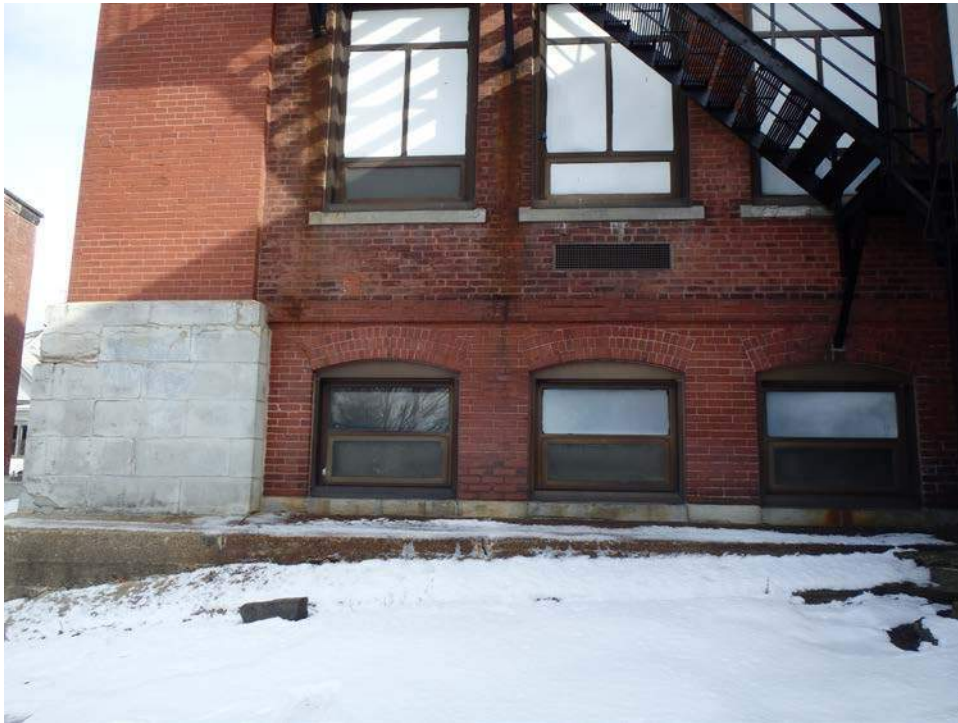
In general, the brick used to construct the building is high fired, good quality brick and is in good condition. The north, south and east elevations were built using a higher quality brick than the west elevation. (Fig. 3) It is typical for lower quality brick to be used at a secondary elevation. Despite its relative lesser quality, the west elevation brick is in good condition. There is a limited amount of

Figure 3. High quality brick used on north, south and east elevations (left) and lesser quality brick on west elevation (right)

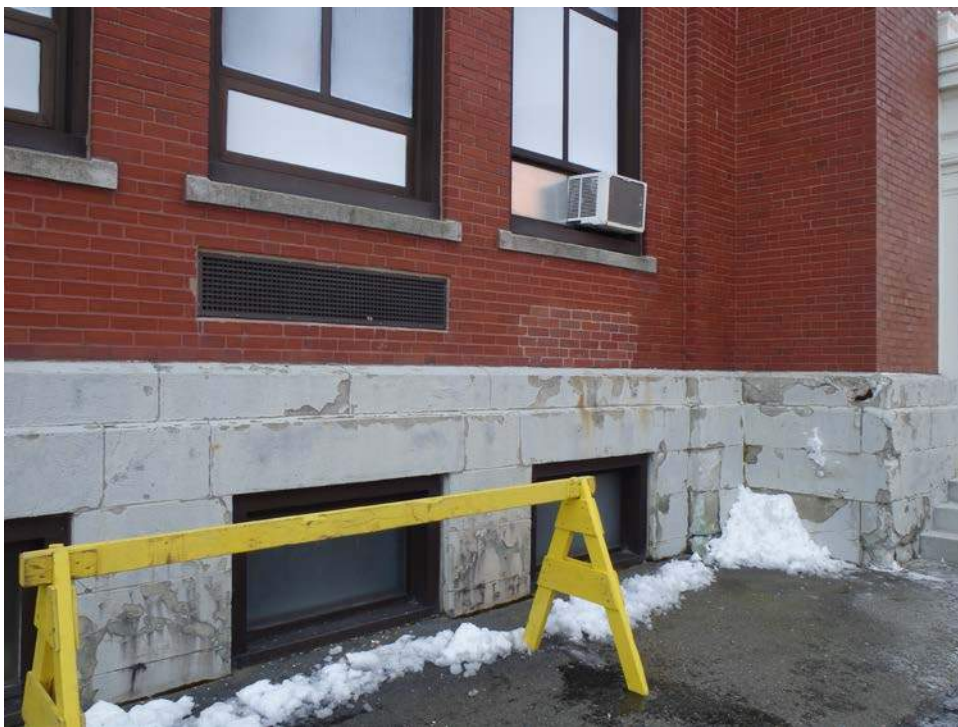
damage to the individual bricks and no apparent evidence of building movement. The brick damage is generally isolated to locations associated with the rusting lintels, deteriorated sills and areas of mortar loss leading to water infiltration. Some areas have been rebuilt with replacement brick. The brick and mortar match is poor. (Fig. 4)

Figure 4. Area of brick infill with poorly matched brick and mortar

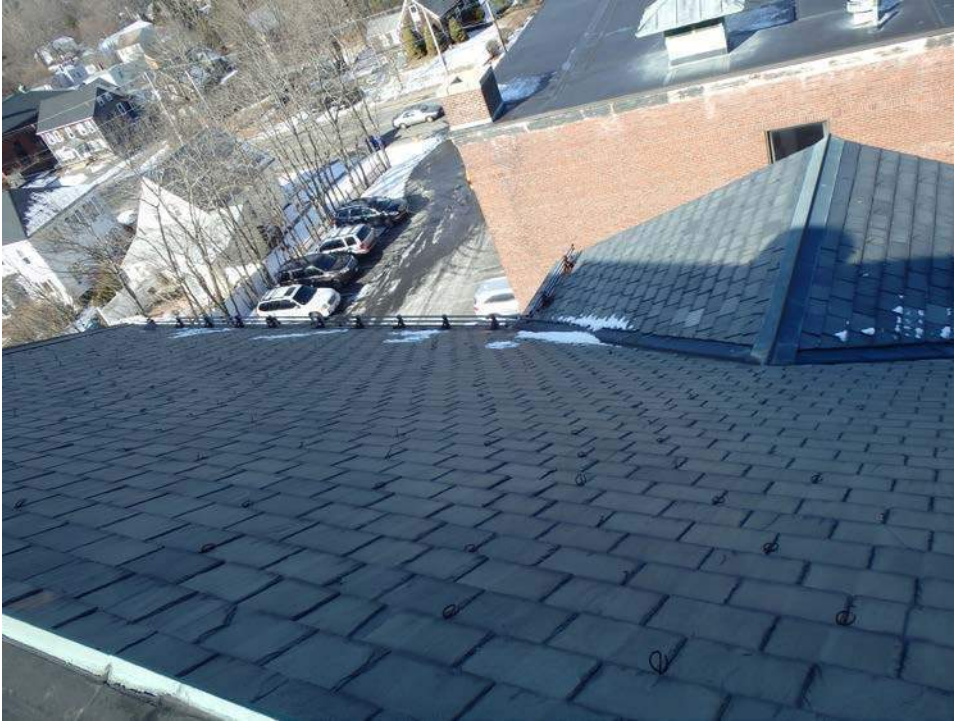
The slate roof is in good to fair condition. It appears to be a non-fading black slate from Monson, Maine. This is a very durable slate that, when well maintained, has a 150-200 year life span. There are large areas of original slate with only isolated individual loose or missing slate. (Fig. 19) There are other locations where areas of slate have been replaced with new slate that does not match the original. (Fig. 20) There are areas at the roof edge where slate have slipped around or beneath the snow rails.

Figure 19. Slate roof showing typical intact condition

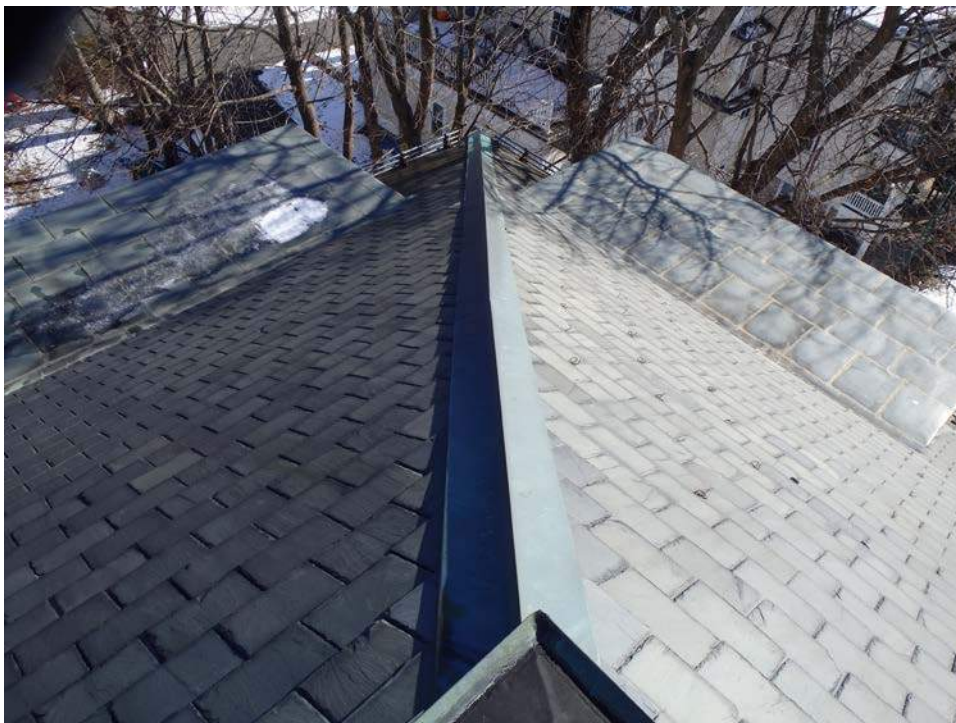
Red copper was used for all of the metal roofing and flashing on the slate roof. The hips, valleys (Fig. 21) and flat seam copper dormer roofs all appear to be in good condition with not visible pin holes, split seams or wear patterns. (Fig. 22)

Figure 22. Red copper flat seamed dormer roofs
