Town of Rockland Community Center At McKinley School

394 Union St. Rockland, MA

Facility Assessment & Planning Study

July 07, 2020

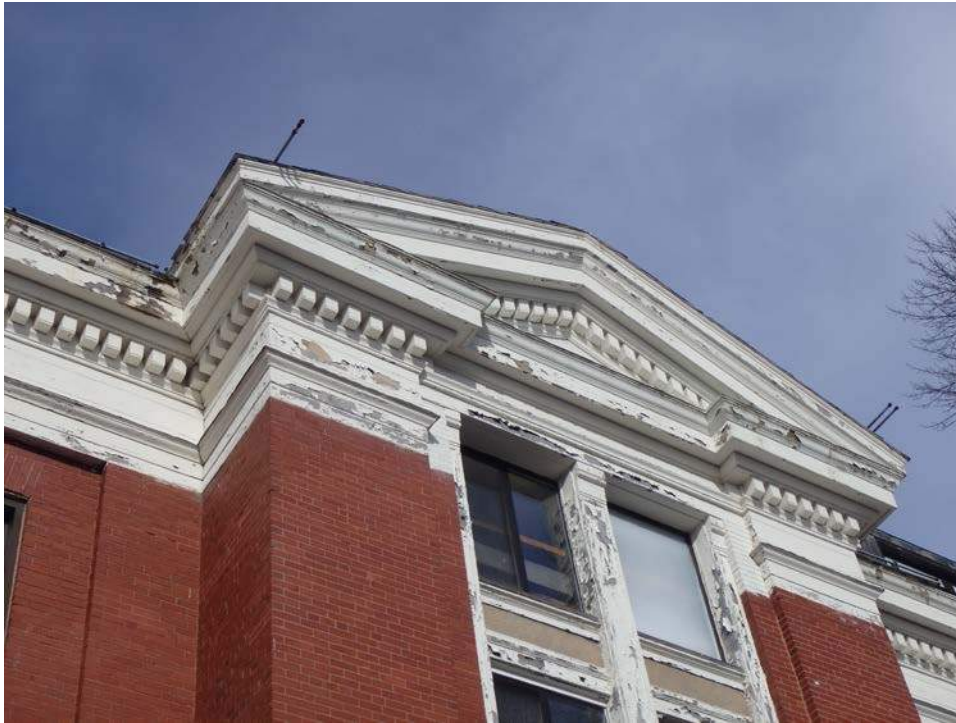
There are metal snow rails located at the edge of the roof. There are brackets approximately every three feet that hold three rails perpendicular to the roof. They are in fair to poor condition. Most of them are rusting and some of the rails have come loose from the brackets and appear to be hanging over the roof edge. (Fig. 23)

Figure 23. Snow rails loose from bracket and projecting beyond roof edge

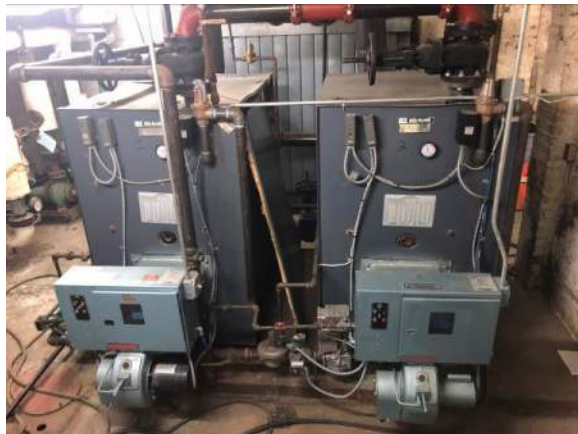
The building heating system is served by two Weil McLain series 688 cast iron sectional boilers that are located in the Boiler room. The boilers appear to be approximately 30 years old and are provided with natural gas burners (Manufactured by Webster - Model JB1G-03-RM7895A-L.15-UL-CSD-1). The boilers are provided with code complaint operating and safety controls. The boilers each have a capacity of 1,703 MBH input 1,358 MBH gross I=B=R output. The boilers appear to be in fair condition; however, the boilers are nearing the end of their useful expected service life of 30 years and one boiler is currently down for repairs to one of its cast iron sections. The boilers are controlled by an automatic heating control system manufactured by Heat Timer (Model HWRQ Platinum).

Existing Hot Water Boilers

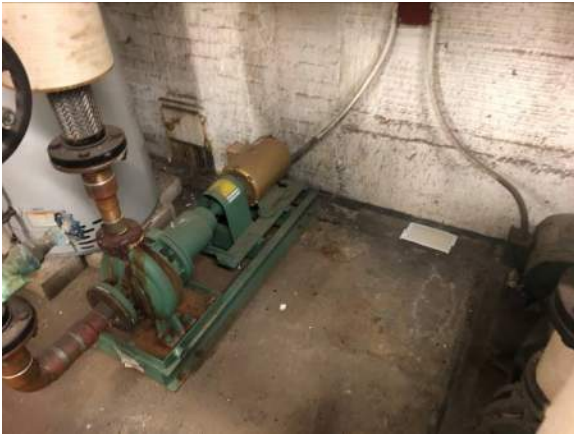
The boilers generate hot water supply at approximately 180 deg F and distribute to an overhead schedule 40 black steel piping system into a common header which distributes to the building heating equipment through four (4) base mounted end suction hot water heating pumps. All of the pumps appear to be in poor condition, and it is our understanding that two of the pumps do not operate. One pump, P-2, in particular appears to be in very poor condition, inoperable and beyond repair. The pumps were manufactured by Taco and are equipped with 3 HP motors.

Existing Hot Water Pump P-4

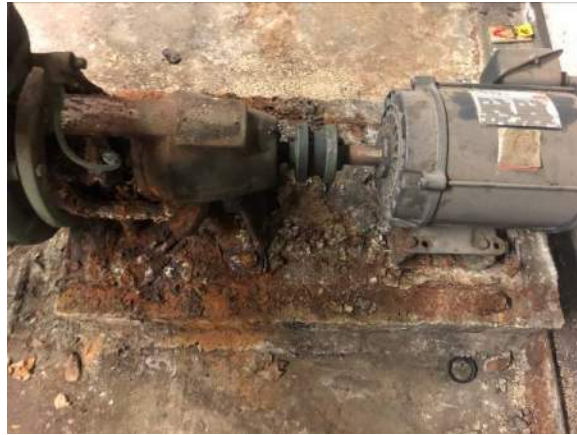
Existing Hot Water Pump P-2

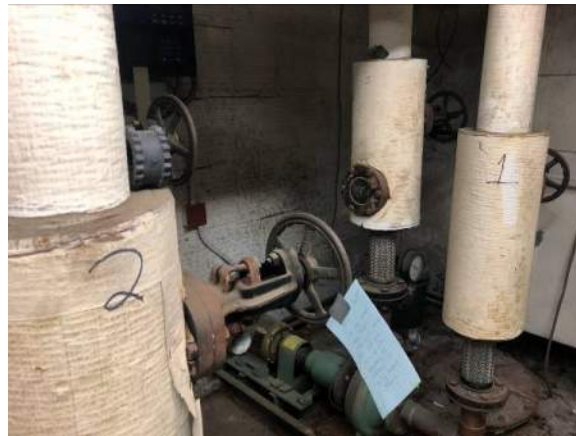
Existing Hot Water Pump P-1

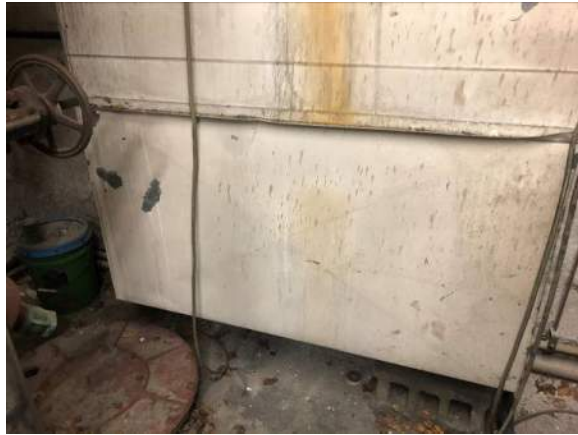
Combustion air for the boiler room is provided through a single existing galvanized sheetmetal duct which has duct openings at approximately 12 inches below the ceiling and 12 inches above the floor. This duct is not provided with a motor operated damper to close off combustion air when the boilers are not operating. The current building code requires motor operated dampers, and therefore this deficiency makes the current installation non code compliant.

Existing Combustion Air Duct, Low Opening (left) and High Opening (right)

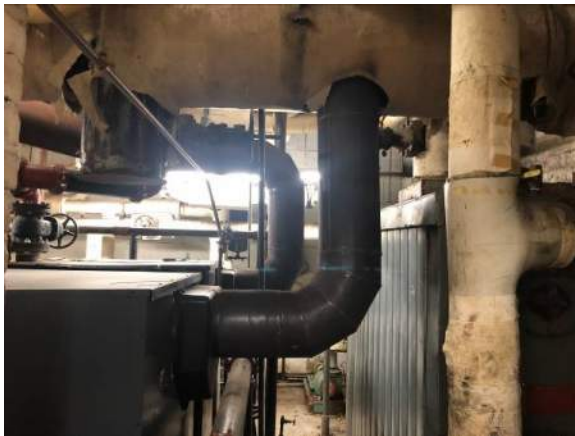
Breeching for the boiler is welded black steel construction and some sections of the breeching are insulated with what appears to be calcium silicate insulation with a canvas jacket. Many areas of the breeching are uninsulated which is non code compliant. The breeching discharges to a masonry chimney which appears to require some repairs. The condition of the chimney liner was not observed during this site visit as the boiler plant was in operation. However, given the age of the chimney, chimney liner repairs and/or replacement with a new internal liner are likely required.

Uninsulated Boiler Breeching

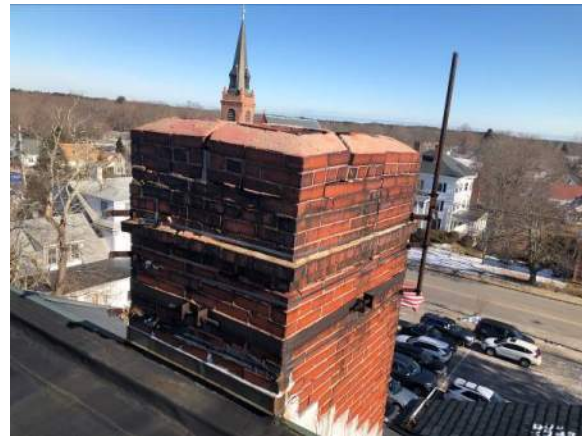
Existing Boiler Chimney

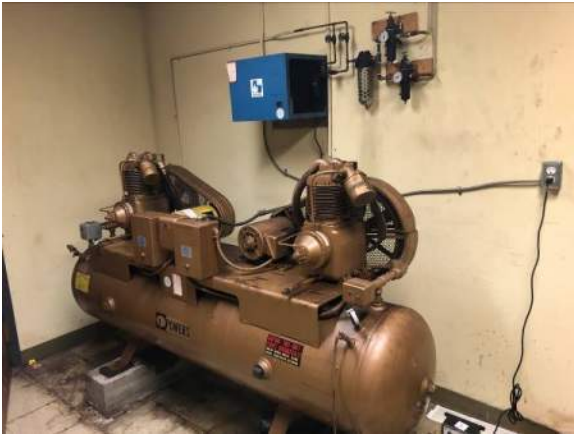
The building HVAC system's automatic temperature controls (ATC) are of the pneumatic type. The ATC compressor is located in a basement electric room, and the control panels are located in the boiler room. The boiler Heat Timer control panel is an electric/electronic control panels that appears to have been installed in more recent years. The majority of the remaining control panels, air lines and control devices appear to be antiquated. The pneumatic compressor consists of a single air storage tank with two tank mounted motors and compressors which generate between 15 and 20 psi of control and pressure for distribution to all control devices throughout the building. Also located adjacent to the storage tank is a refrigerated air dryer. The compressor and air dryer appear to be in good condition; however, the building automatic temperature control lines, t-stats and remaining components appear to be antiquated and should be replaced and upgraded.

Existing ATC Compressor and Air Dryer

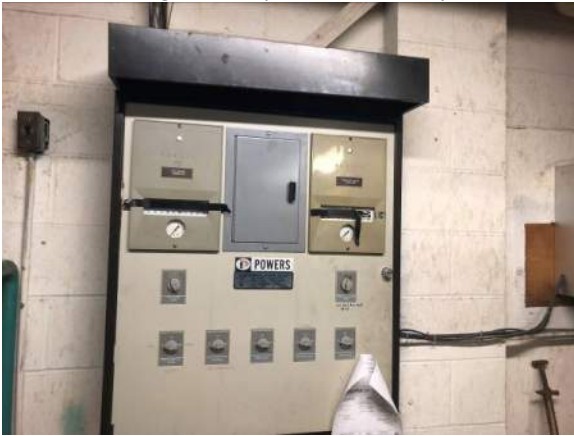
Existing ATC Pneumatic Control Panel

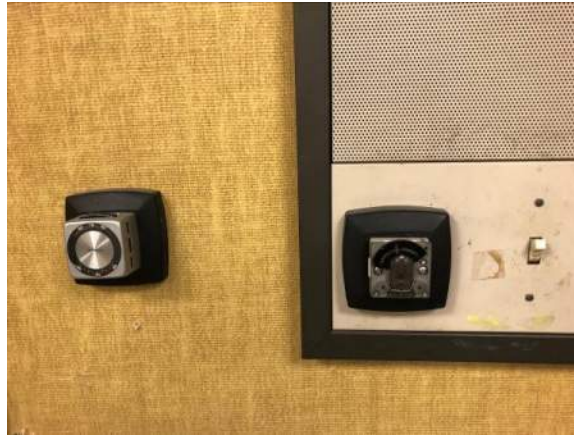
Existing Pneumatic T-Stats

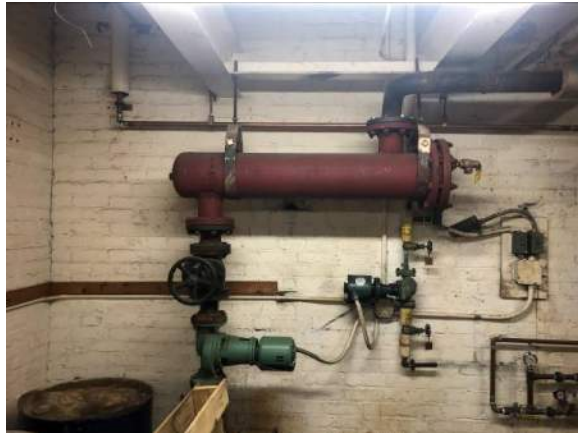
There is an abandoned in place hot water heat exchanger, circulator pumps and ceiling suspended expansion tanks located in the Storage room adjacent to the existing Boiler room. We recommend that this abandoned in place equipment is removed. There are also several abandoned in place T-stats located throughout the building.

Abandoned in Place HW Heat Exchanger

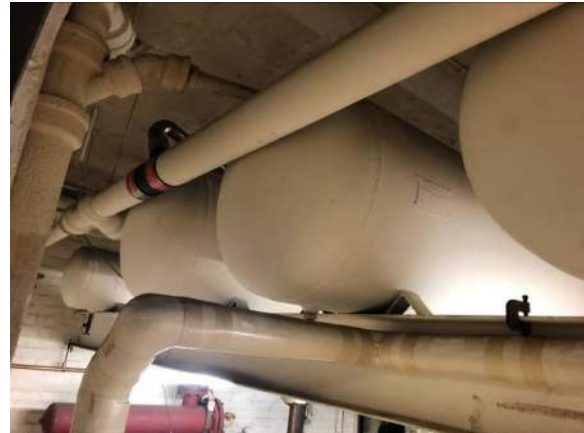
Abandoned in Place Expansion Tanks

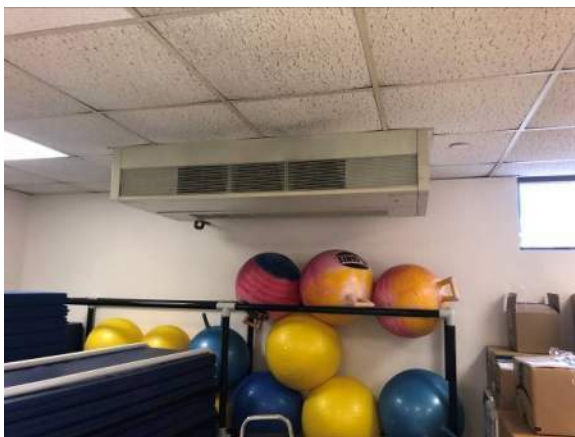
The Basement building classrooms/storage rooms/offices are provided with ceiling mounted free discharge type classroom unit ventilators located at the ceiling. These units appear to be provided with outside air from a wall mounted louver which connects to each unit ventilator through an uninsulated galvanized outside air duct. Return air is drawn directly at the base of each unit and redistributed to the space. The overall condition of the ceiling units was noted to have surface soiling and some damage, however most units appear to be operating and maintaining reasonable heating temperature control. Exhaust air is removed by exhaust registers that are ducted to a roof mounted exhaust fan systems. Most of the exhaust grilles observed were noted to have surface soiling. All units were noted to be in excess of 50 years old and all equipment has exceeded its maximum serviceable life and in need replacement.

Lower Level- Unit Ventilator

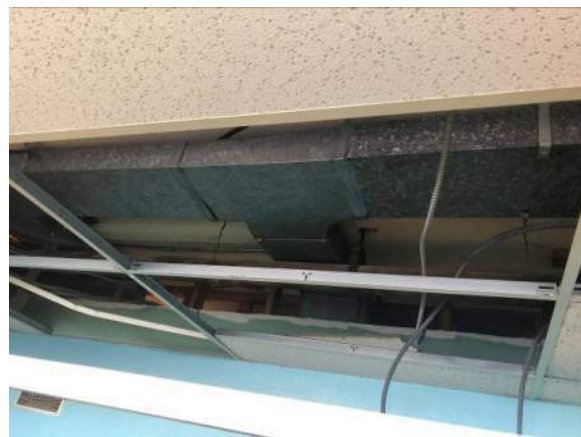
Lower Level- Ductwork

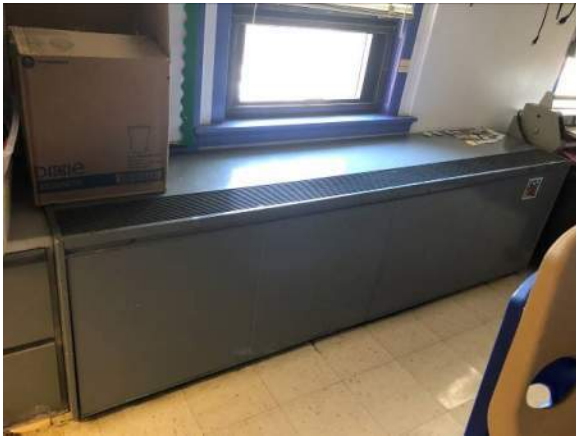
The upper-level building classrooms located on First, Second and Third floors are typically provided with wall mounted classroom unit ventilators located at the exterior wall of each classroom. These units are provided with outside air drawn from a wall mounted louver and return air is drawn directly at the base of each unit. Also located in the classroom located in the central area of the building are ceiling or sidewall exhaust register which communicates to a roof mounted exhaust fan through a galvanized sheet metal exhaust ductwork system. Classrooms located at the North and South ends of the building are typically exhausted by room Wall Exhauster units that communicate directly to the outdoors through a wall exhaust air louver. In general, all classroom unit ventilators and exhaust systems were in excess of 50 years old, beyond their useful expected service life and are in need replacement.

Classroom Unit Ventilator

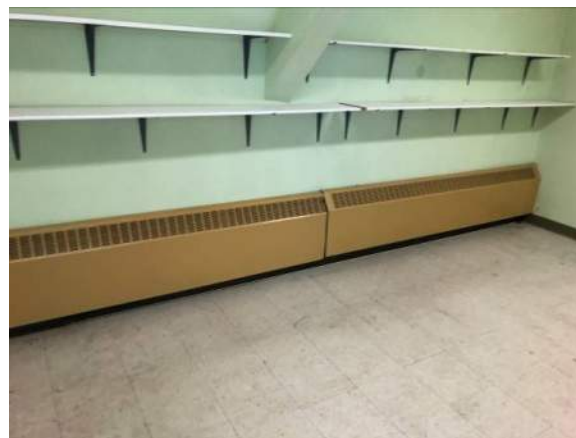
Storage rooms in the basement and on the third floor are typically heated by wall mounted fin tube radiation heating. The basement fin tube radiation and enclosures appear to be in poor condition. The third floor radiation appears to be in fair condition.

Third Floor Storage Room – Fin Tube Radiation

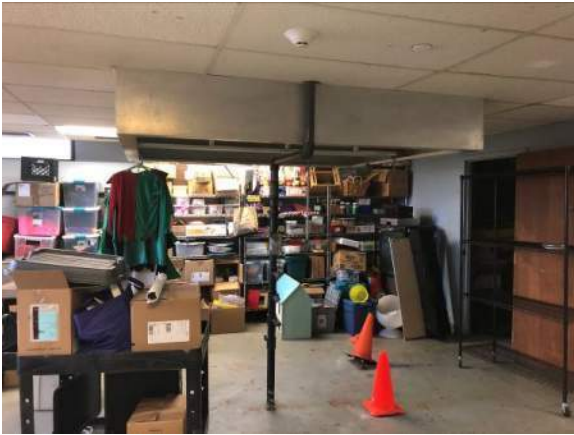
The kitchen area is provided with an abandoned in place kitchen exhaust hood located over location of previous installed but since removed kitchen equipment. The abandoned in place dishwasher equipment does not have any exhaust hood or direct ductwork connections. The kitchen hood was noted to be antiquated and has reached its maximum serviceable life. Make up air for the kitchen hood appears to be through the use of a ceiling suspended unit heater and adjacent heating and ventilation unit that is located in an adjacent storage closet. The H&V unit also appears to serve other areas of the basement such as the Cafeteria and adjacent corridor.

Kitchen Exhaust Hood

- Replace existing kitchen exhaust hood and fan. Provide make-up air unit to serve the kitchen.
- Replace the building control systems with a new direct digital control (DDC) and building energy management system (BMS).

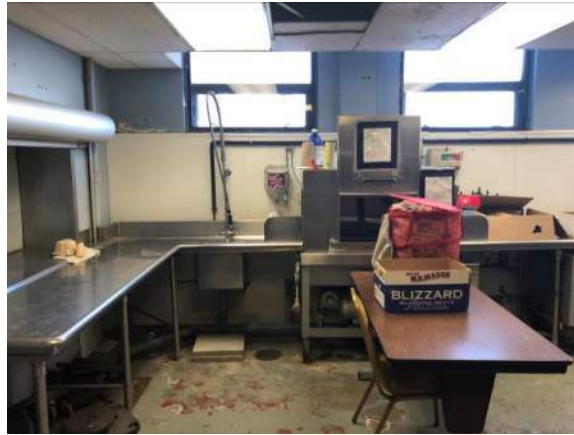
Abandoned Kitchen Dish Washer

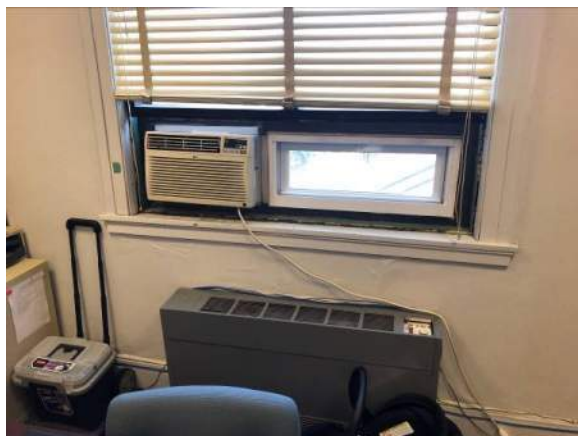
Several offices in the administration area are not provided with mechanical outdoor supply ventilation air. These office areas are typically provided with a limited amount of exhaust ductwork which is galvanized sheetmetal construction that connects to a roof mounted exhaust fan. The majority of outdoor ventilation air appears to be through the use of operable windows located in the exterior wall. The majority of offices appear to be served by wall mounted hot water / DX direct expansion cooling fan coil units. It is our understanding that the cooling operation no longer works on these units and air conditioning is now provided by Window AC units in some offices. Several offices observed also had ceiling mounted paddle type fans. Two adjoining offices are served by one unit ventilator. In this case the wall partition was cut around the existing unit ventilator. In general, the office heating and air conditioning equipment is in poor condition, beyond its useful service life and in need of replacement. A new mechanical ventilation air system should be provided for the administration office areas.

Administration Office – Window AC and HW Fan Coil

- Replace existing Administration heating and air conditioning systems. Provide new heating, ventilation and air conditioning for administration office areas.

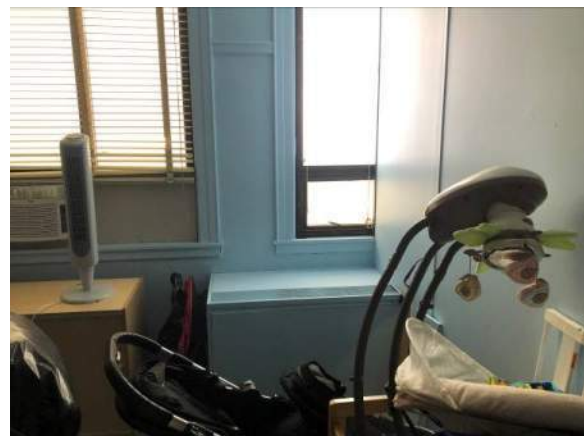
Administration Office – Unit Ventilator

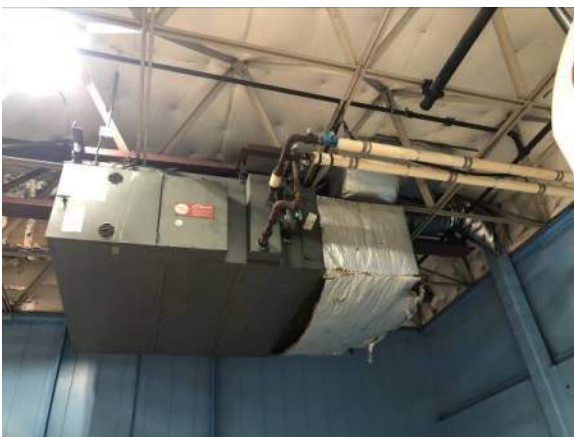
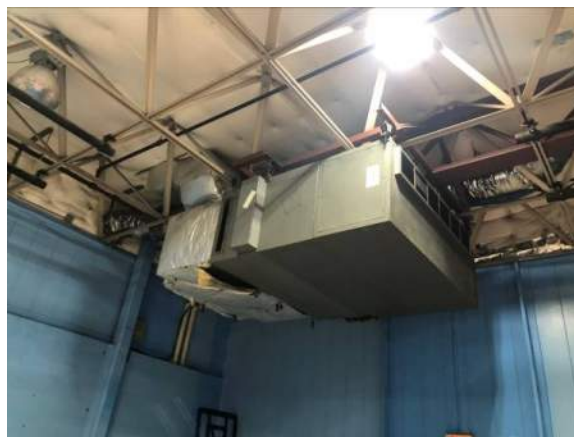
The gymnasium is provided with two ceiling mounted horizontal discharge heating and ventilation air handling units. The units were manufacturer by Herman Nelson (Model AUDIVent). Each air handling unit appears to be provided with a hot water heating coil, supply fan, filters, return air drawn at the rear of the unit, and an outside ventilation air duct that is connected to a roof mounted hood. Supply air is provided through the unit discharge grille. It was noted that the insulation on the return and outside air duct had extensive damage and generally in a state of disrepair. The units' discharge grilles were noted to be soiled. The air handling equipment, ductwork and insulation would be considered in very poor condition and generally need of replacement.

Gymnasium – Heating & Ventilation Units

- Potentially add partial or full air conditioning to classrooms.
- Replace Gym, and Cafeteria/Kitchen heating and ventilation units. Potentially add full or partial air conditioning to these areas of the building.

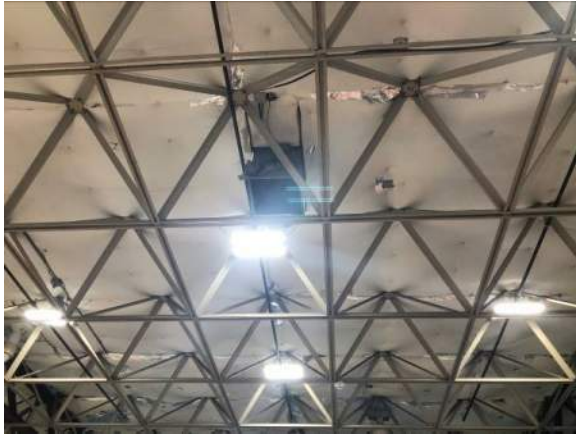
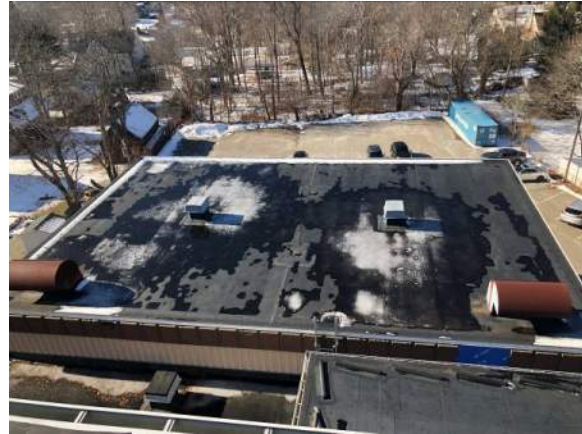
The gymnasium was also provided with two individual roof mounted exhaust fans which vent directly at the roof level. The units are not sized for economizer control and only maintain minimum ventilation air circulation. The exhaust fans were noted to be in very poor condition and generally need replacement.

Gymnasium – Exhaust Fan (left) and Gymnasium Roof – Fans and Roof Hoods (right)

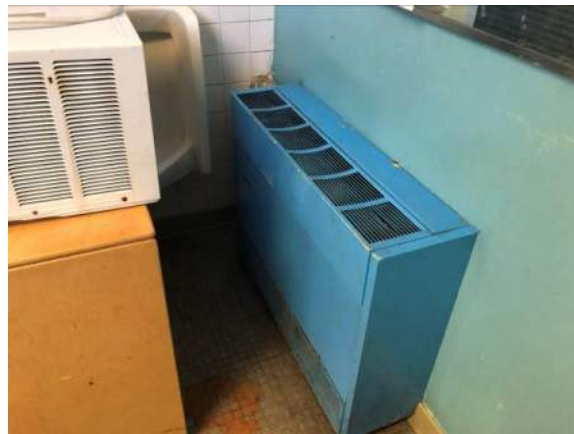
The individual public toilet areas are typically heated by hot water convector units that appear to be in poor condition. The toilet rooms also appear to all be provided with either ceiling or wall mounted exhaust registers generally in back of the toilet fixtures. The registers communicate to individual roof mounted exhaust fans through a galvanized sheetmetal exhaust ductwork system. All exhaust registers were noted to be soiled and appear to be original to the building. Make up air for the exhaust system is typically provided through the use of door. In general, the toilet room heating equipment, exhaust grilles/ductwork and exhaust fans appear to be in poor condition and in need of replacement.

Toilet Room – Convactor Heater

- Replace existing entryway, hallway and toilet room hot water convectors with new hot water convectors. Hallways should be provided with code required ventilation air. Toilet rooms should be provided with new code complaint exhaust air systems.

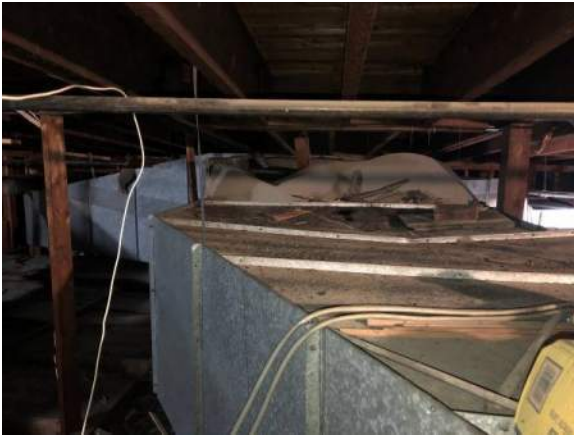
In general, the majority of the building exhaust air fan equipment and systems appear to be over 50 years old and in need of replacement. While some fans may have been replaced in subsequent years, they all appear to be in poor condition and in need of replacement.

Attic – Exhaust/Ventilation Ductwork

- Replace existing utility/storage room hot water radiation/convectors/unit heaters with new hot water heating equipment
- Replace existing exhaust fans, roof hood ventilators and associated exhaust air ductwork distribution system.

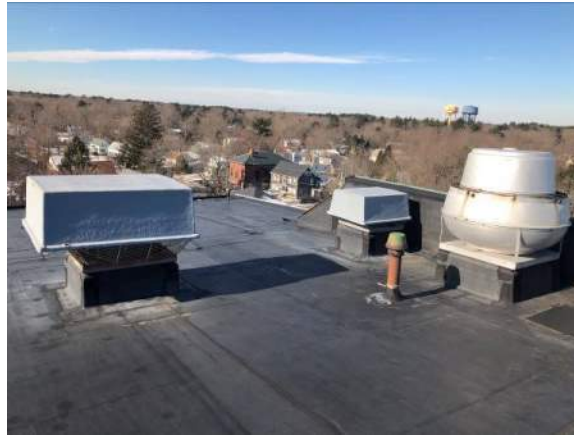
Roof - Exhaust Fans

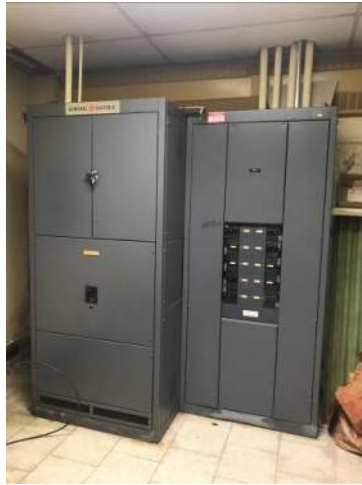
The main switchgear was manufactured by GE and is in fair condition. The switchboard does not have space provisions for additional future breakers. Most other equipment including starters, disconnect switches, etc. are generally in poor condition and should be replaced.

Main Switchboard

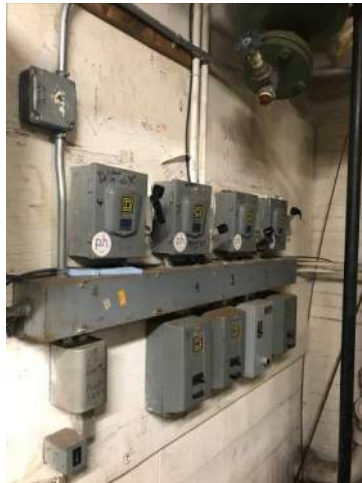
Starters & Disconnect Switches

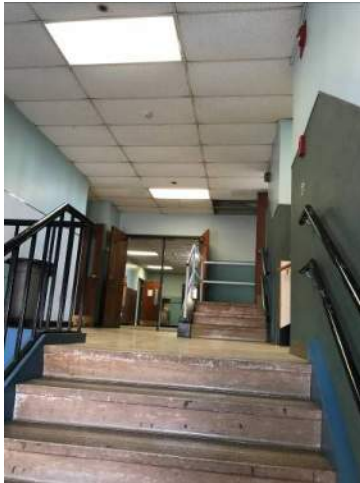
Corridor Lights

The lighting has been upgraded over the years with fluorescent fixtures and T8 lamps. The existing wiring and switches were reused. The corridor lighting consists of 2x2 and 2x4 recessed fixtures with acrylic lens and T8 lamps. The corridor lights are controlled with local switches.

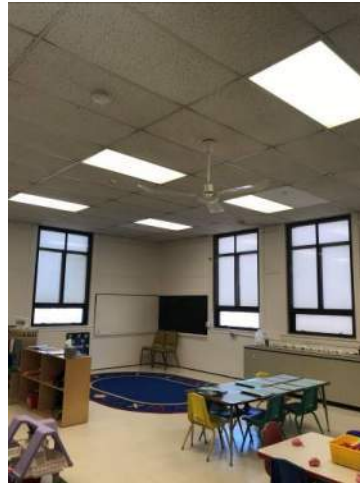
Classroom Lights

The typical classroom has recessed 2x4 fixtures with acrylic lens and T8 lamps. The fixtures are controlled with local switches, as well as, a ceiling occupancy sensor.

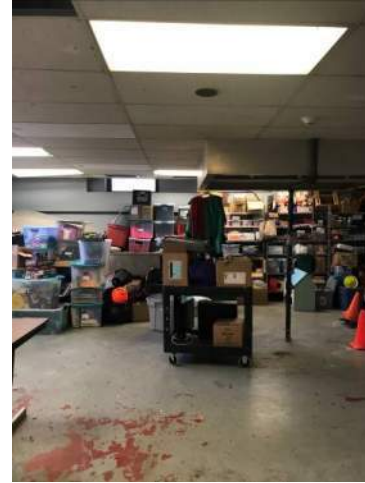
Inactive Kitchen Lights

Kitchen lighting has recessed 2x4 lensed troffers with T8 lamps. Kitchen is inactive, used as storage.

The florescent lighting fixtures are generally of the utility grade and are in fair to poor condition.

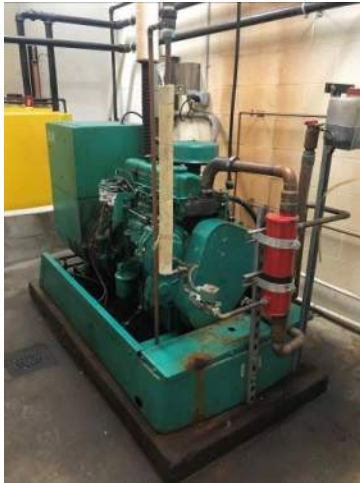
Interior Generator

The 100 ampere automatic transfer switch and emergency panelboard are located in the Main Electric Room. The generator was manufactured by Onan, the ATS is an ASCO switch. The system equipment is in fair condition.

The emergency standby system, due to code changes, no longer meets current codes to service life safety egress lighting and exit signs. Egress lighting and exit signs with battery back-up are required throughout.

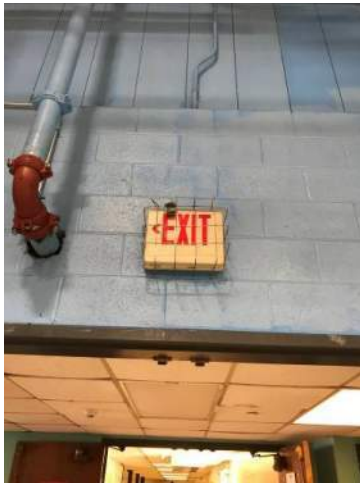
Exit signs are generally internally lit and condition varies from fair to poor. Coverage is generally inadequate. The gym exit signs have protective wire guards.

Internally Lit with Wire guard

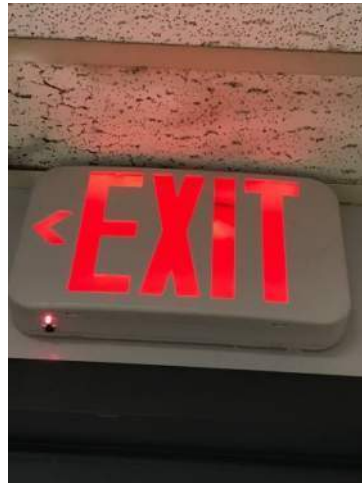
Internally Lit Exit Sign

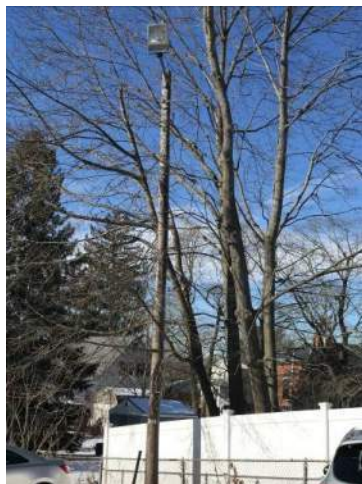
Rear Parking Area Pole Lights

Site lighting for front drop-off and rear parking area is by utility pole-mounted HID flood lighting fixtures. Building mounted HID wall packs are also used to light the rear parking lot. The light fixtures are not of the cutoff type. Some exterior doors have wall sconces while others do not have wall sconces and those that do vary from poor to good condition. Exterior lighting is inadequate and generally in poor condition.

- Provide allowance for exterior site lighting fixtures for area lighting consisting of pole mounted long life, energy efficient LED luminaries in the parking areas. Building perimeter fixtures will be wall mounted LED over exterior doors. The exterior lighting will be connected to the automatic lighting control system for photocell on and timed off operation. All exterior lighting will be of the cut-off type. Replace existing building site lighting with LED.

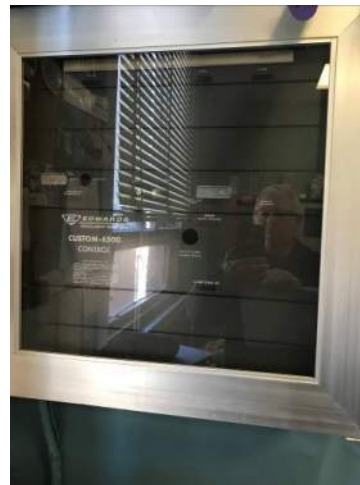
Intercom Paging Console

The incoming communications services enter the building overhead from a utility pole on Union Street. The intercom/paging system is located at the Main Office. The system is an Edwards-6500 Series console; however, the system is non-functional. The classrooms have a clock speaker. The call-in switch has been removed. Classrooms do not have telephones or other means to communicate with the Main Office.

- Provide an IP public address system to communicate between Admin and classrooms.
- Provide two-way call box system at elevator lobbies.
- Interlock elevator with fire alarm system.
- Provide a door entry system with video/intercom at the main entrance.
- Repair/replace the CCTV DVR.

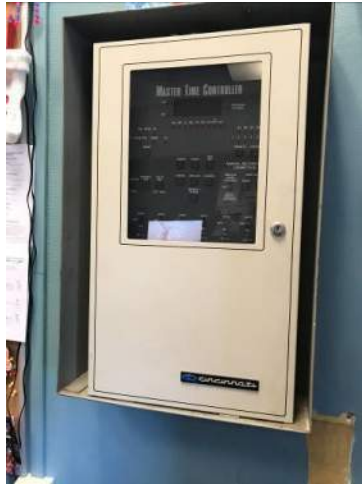
Time Controller

There is a Cincinnati master time clock controller located in the Main Office, but is non-functional. The clocks have been replaced with battery operated clocks.

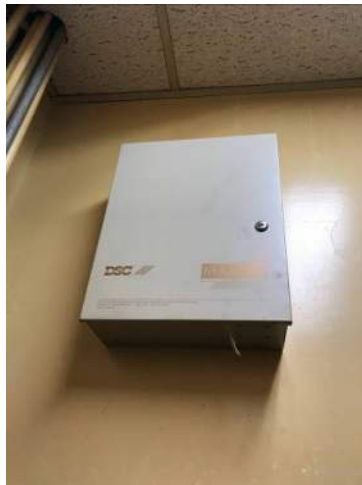
Security Control Panel

There is a DSC security system present with motion detectors and exterior door magnetic contacts, however, not all doors have been provided with magnetic contacts. A security keypad is located at the main lobby.
